BANK EROSION IN THE BERG RIVER ESTUARY

Causes and Concerns

February 2021

Anchor Research & Monitoring (Pty) Ltd
in association with Zutari

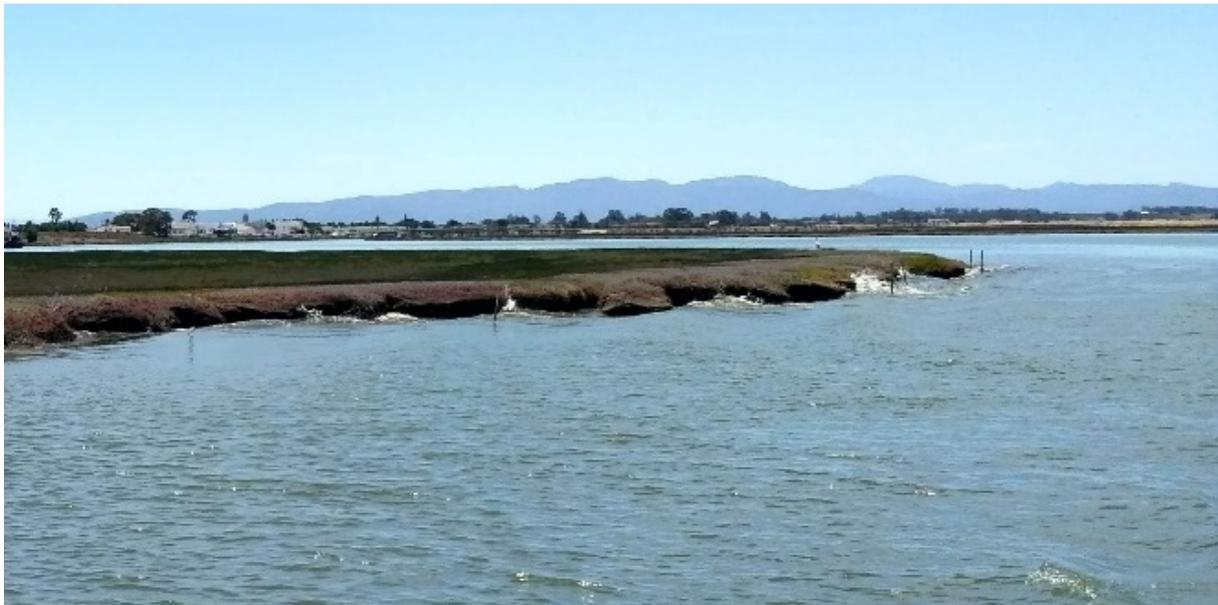
Considering the position of the salt marsh, which is predominantly on the inside of a bend, it is likely that the main cause of erosion is from waves and not from flow as this should be in an area of sediment deposition due to flow. The bank is exposed to winds from the south and is also in a section of the channel which gets frequent boat traffic, lying between Port Owen and the mouth and it is likely that waves are the dominant cause of erosion at this site. **Figure 22** shows the effects of boat waves on the bank.

Figure 22: Marker poles showing a previous bank position and the current eroding bank at Admiral Island. The effect of boat waves from the wake of the boat can also be seen. (Photo: Martin Kleynhans)

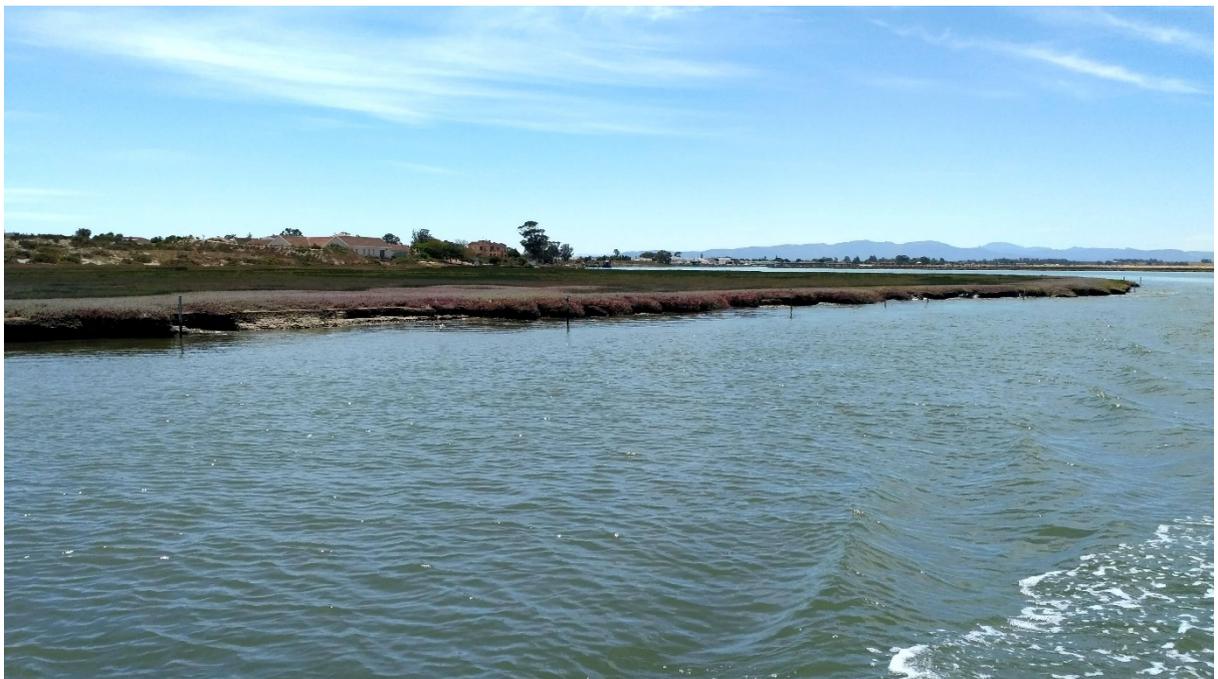
Figure 23: Marker poles showing a previous bank position and the current eroding bank at Admiral Island (Photo: Martin Kleynhans)

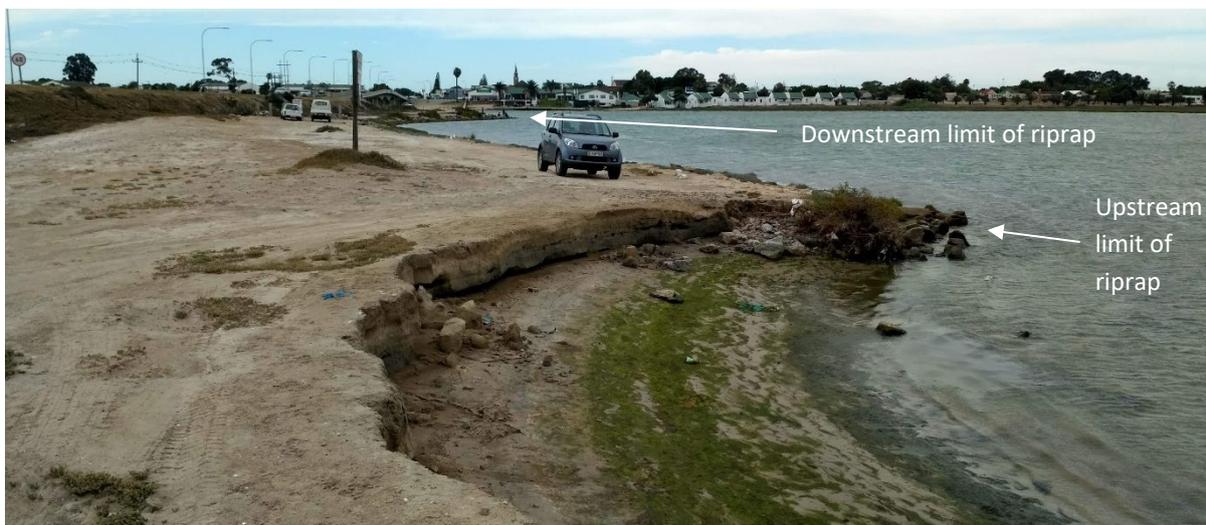
The bank upstream of Carinus Bridge (**Figures 18-20**) has been retreating for some time. In the early 2000s riprap revetment was constructed for a section of the bank, which is discussed in Section 6.2. The riprap has performed very well and is in good condition. The bank upstream and downstream of this however has retreated further, including the left bank through the bridge section and downstream to the salt marsh. The position of the bank upstream of the riprap revetment appears to have retreated slightly and the bank downstream of the revetment appears to have retreated even more as can be clearly seen in **Figure 55**.

Figure 25: Bank erosion just upstream of the riprap revetment. The extent of the riprap revetment is shown. Photo is looking downstream towards Carinus Bridge. (Photo: Martin Kleynhans)

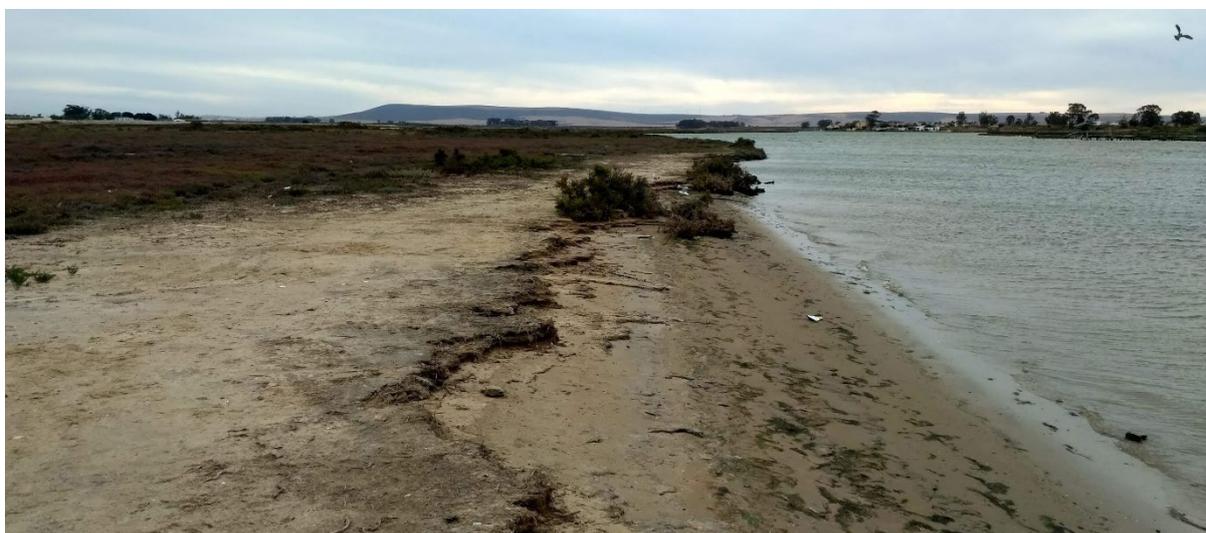
Figure 26: Bank erosion downstream of the Carinus Bridge. Photo is looking downstream. The likely cause of erosion here is flow through the bridge section and boat waves. (Photo: Martin Kleynhans)

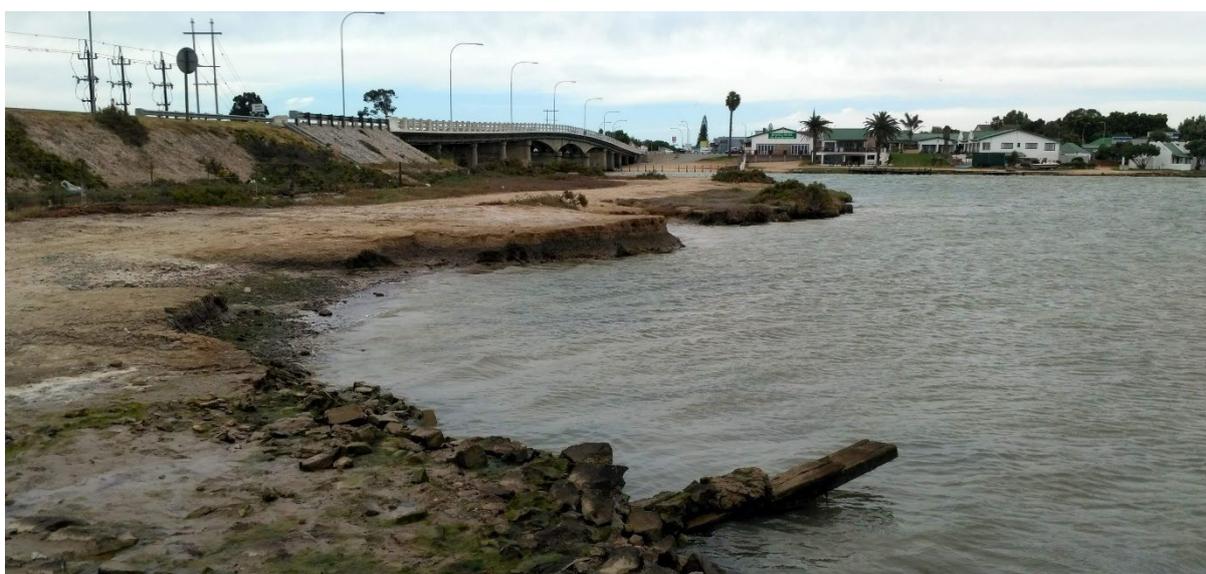
Erosion here could be due to flow, being located on the outside of a bend, and wind and boat waves. On the day of the site visit the bank was visibly eroding due to wind waves during a strong southeaster, with cloudy water along the bank caused by suspension of fines from the bank.

Figure 27: Bank erosion downstream of the riprap section showing the wind waves. Photo looking downstream. (Photo: Martin Kleynhans)

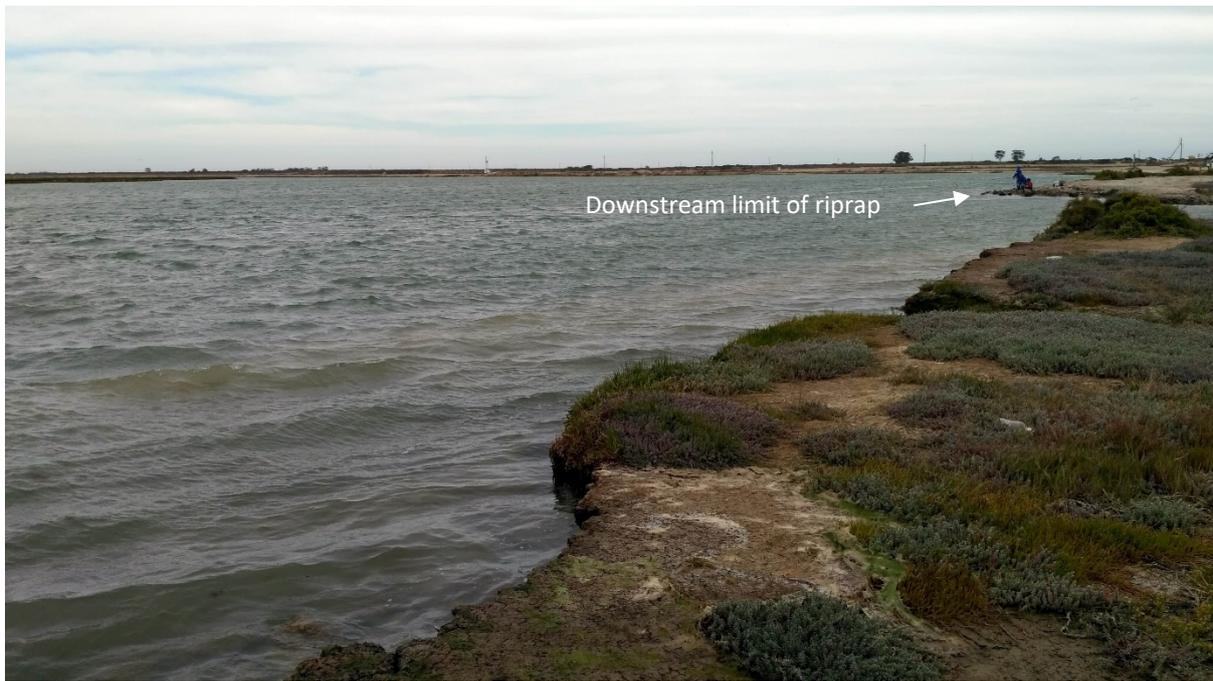
Figure 28: Bank erosion downstream of the riprap section, showing the wind waves eroding the bank and the cloudy water along the bank indicating suspension of fines from the bank. Photo looking upstream. (Photo: Martin Kleynhans)

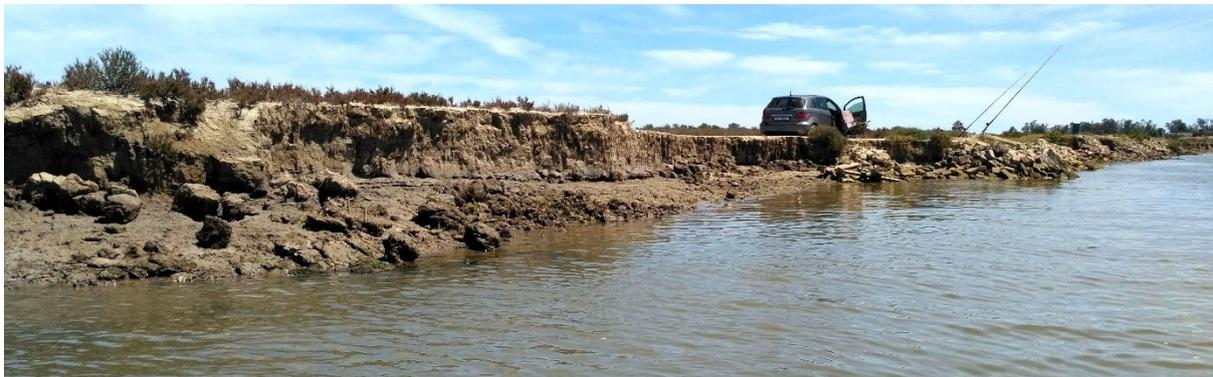
Figure 33: Steep and eroding bank in the foreground and attempts at erosion protection in the background. Photo looking downstream. (Photo: Martin Kleynhans)

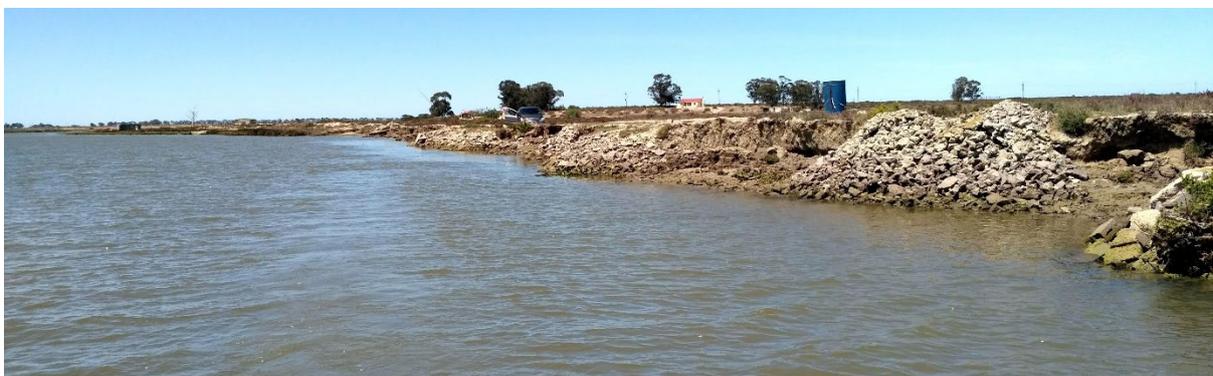
Figure 34: Attempts at erosion protection by dumping of rubble. Photo looking upstream. (Photo: Martin Kleynhans)

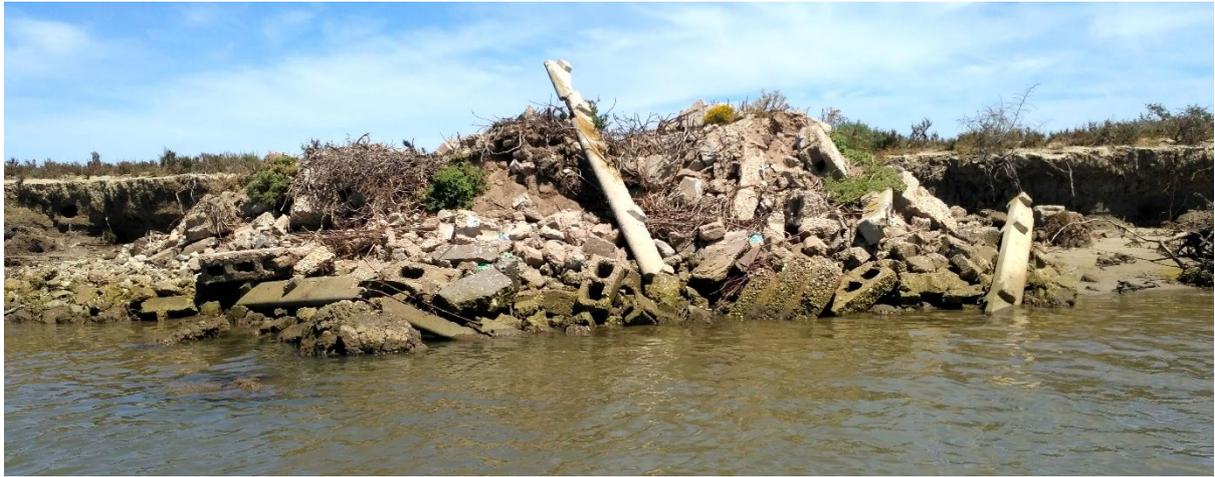
Figure 35: Typical rubble that has been dumped to protect the bank. (Photo: Martin Kleynhans)

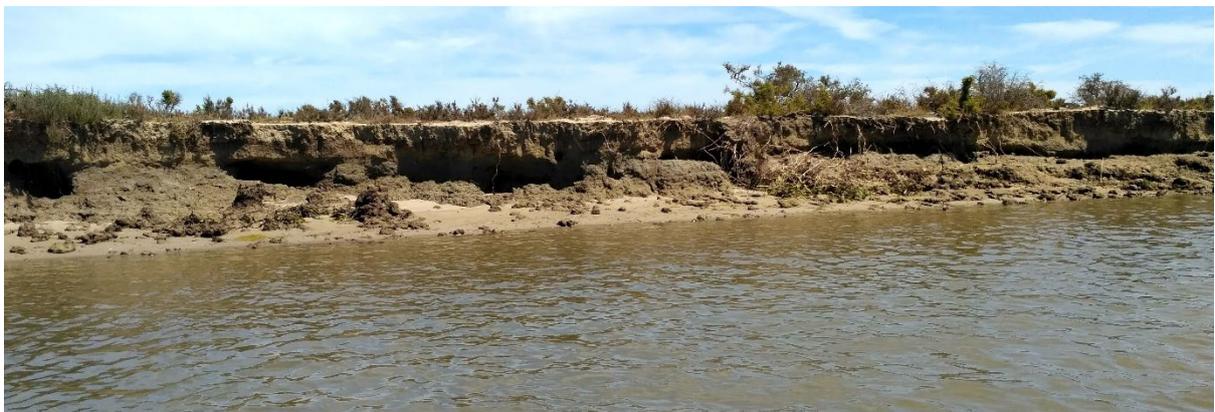
The location of the erosion problem, on the outside of a bend, suggests that flow is playing a significant part in the erosion of the bank. It is likely that the bank erosion at Kuifkopvisvanger is part of a long-term natural process where the channel is migrating laterally over time towards the west, as typically occurs in alluvial meandering rivers. Stabilisation of the bank should then be informed by the value of the habitat that is potentially being lost, especially in the context of the reduced habitat in the estuary due to anthropogenic development. New habitat may be forming on the opposite bank as the channel moves westward.

Figure 36: A section of the bank where no rubble has been dumped showing the mechanism for erosion which consists of progressive undercutting of the steep bank until collapse occurs and the bank position retreats. (Photo: Martin Kleynhans)

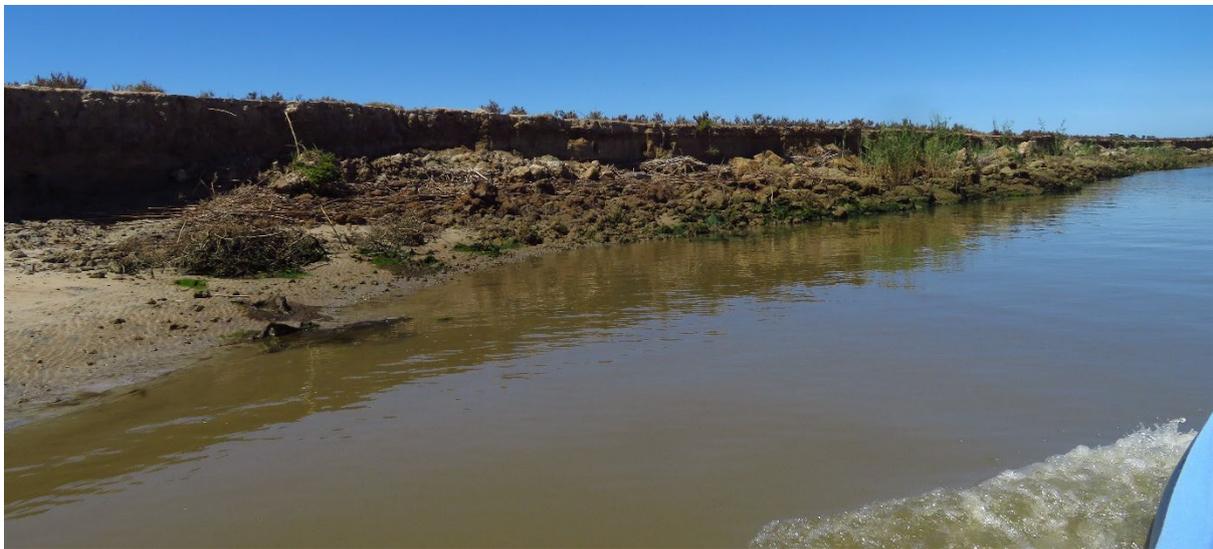
The location of the erosion problem, on the outside of a bend, suggests that flow is playing a significant part in the erosion of the bank. It is likely that the bank erosion at Kliphoek is part of a long-term natural process where the channel is migrating laterally over time to the southeast, as typically occurs in alluvial meandering rivers. Stabilisation of the bank should then be informed by the value of the habitat that is potentially being lost, especially in the context of the reduced habitat in the estuary due to anthropogenic development. New habitat may be forming on the opposite bank as the channel moves southeastward.

Figure 40: Eroding section of the bank at Kliphoek. (Photo: Martin Kleynhans)

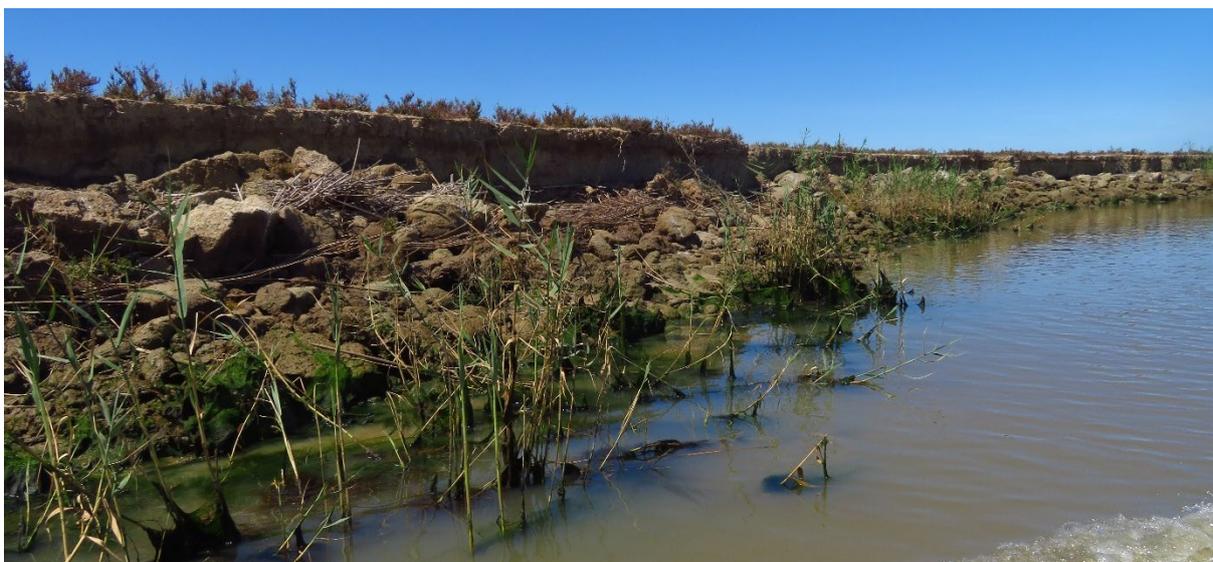
Figure 41: Eroding section of the bank at Kliphoek with some reeds growing in front. (Photo: Martin Kleynhans)

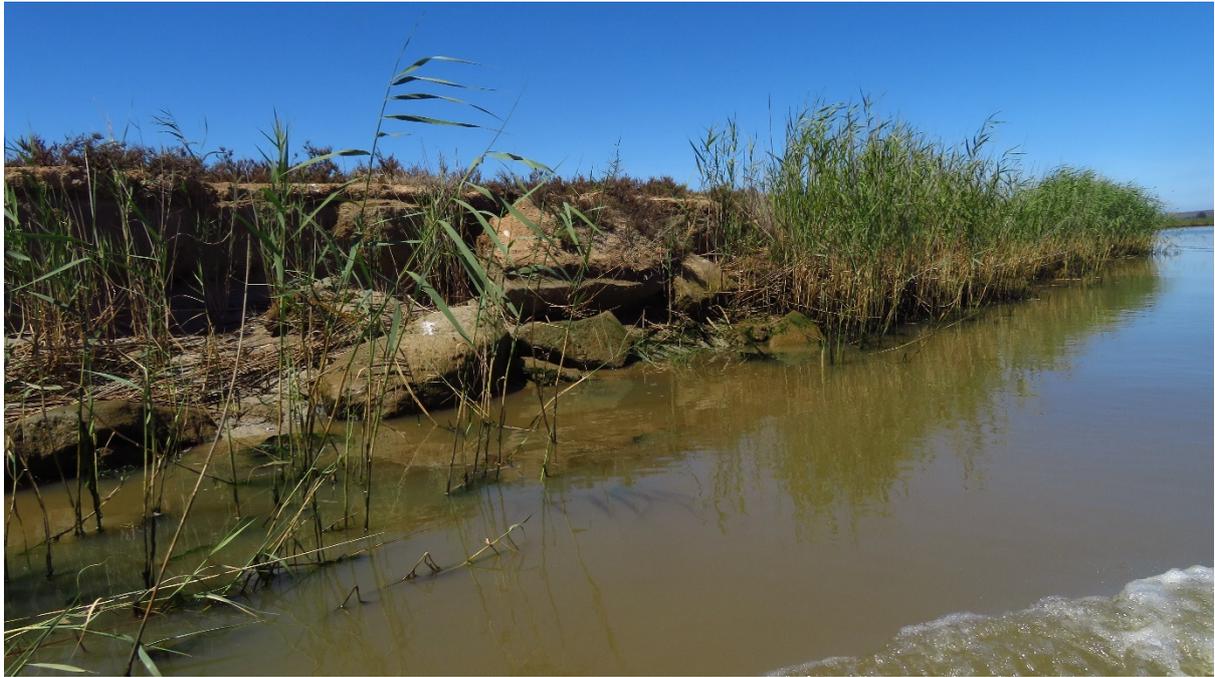
Figure 42: Example of unstable bank (left) and reeds stabilizing the bank and protecting the bank from wave and flow erosion (right), at the downstream end of the Kliphoek site. (Photo: Martin Kleynhans)

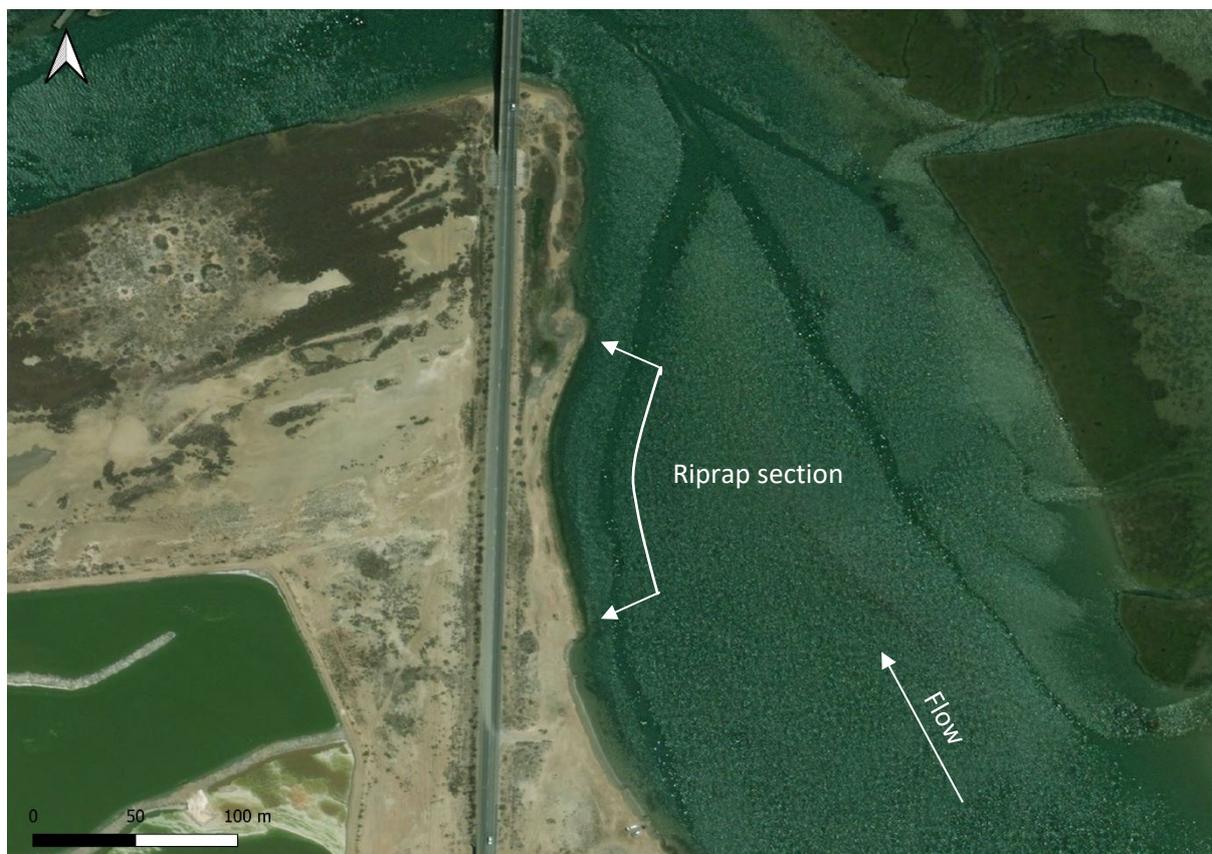
Figure 55: Satellite view of the channel and bank upstream of Carinus Bridge with the section protected by riprap shown. The position of the riprap section compared to the rest of the bank upstream and downstream demonstrates the continued bank retreat (Microsoft Bing image, date circa 2015)

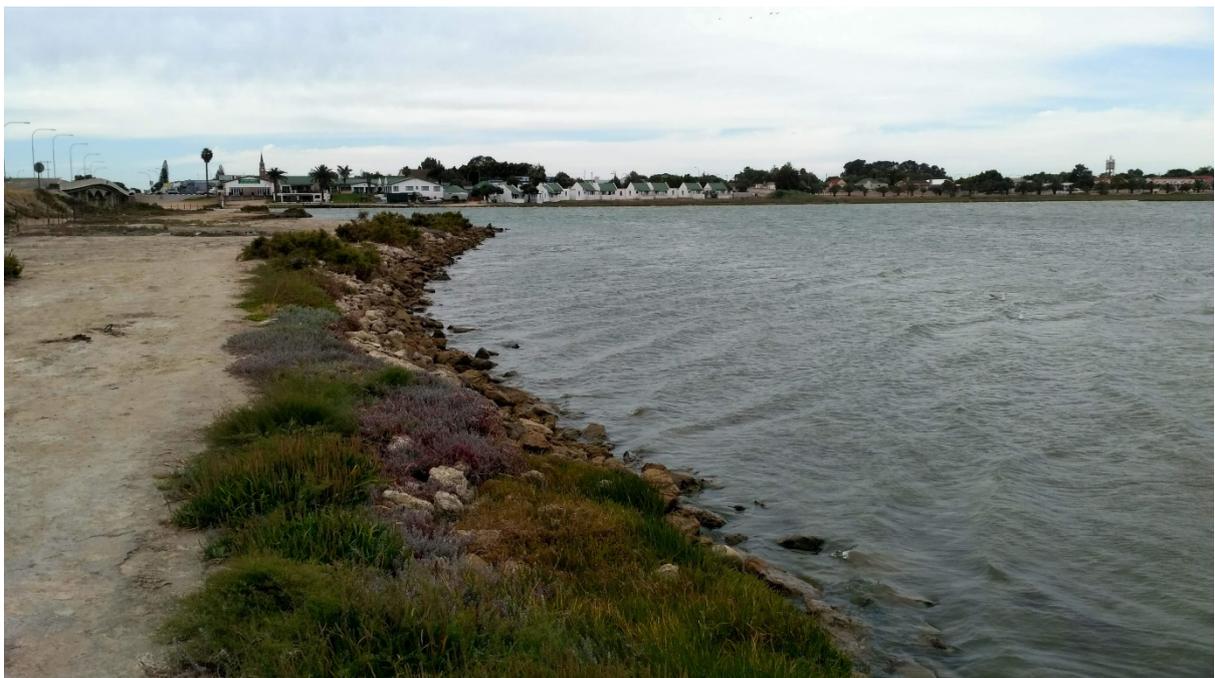
Figure 57: The riprap at Carinus Bridge looking downstream towards Carinus Bridge. The section of riprap further away in the photograph, facing to the southeast has less vegetation than the rest and this could be due to increased exposure to wave energy in this area. (Photo: Martin Kleynhans)
