# **Mouth Management Plan for the Klein Brak Estuary**

October 2018

Western Cape Estuary Management Framework and Implementation Strategy

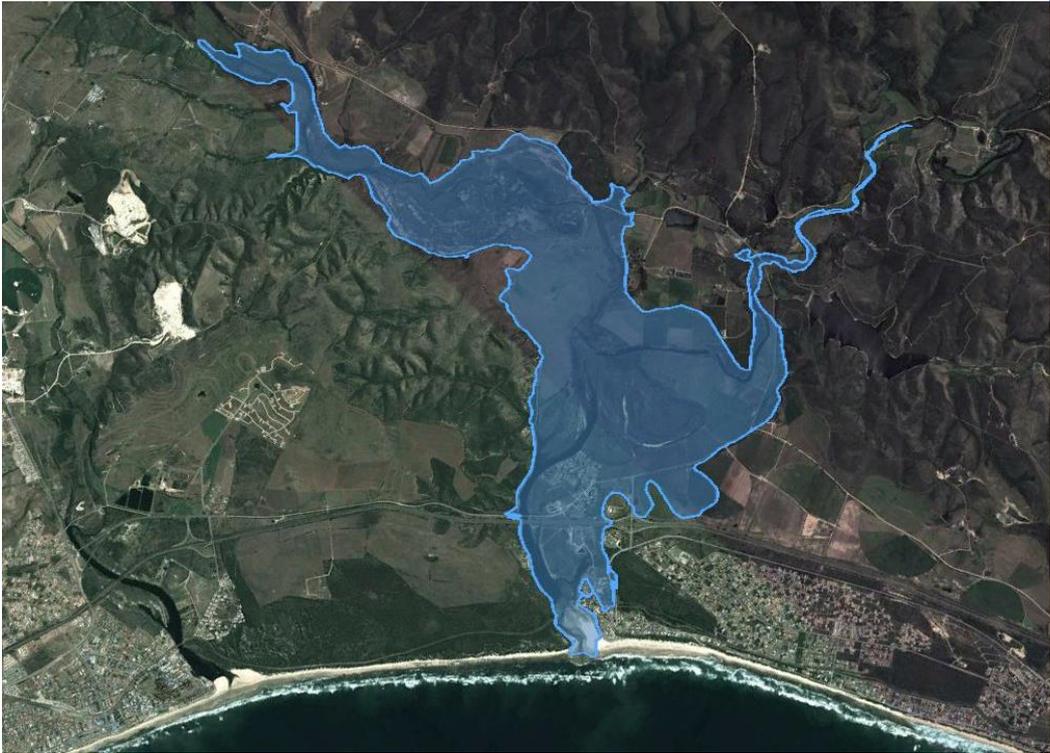
Threat	Discussion
<p><b>Location</b></p>	<p>The Klein Brak Estuary is situated within the southern coastal belt, and is approximately 12km north of Mossel Bay (Figure 3.1). Two major tributaries, the Brandwag River and the Moordkuil River join approximately 3 km from the coast to form a well-developed flood-tidal delta (DWA 2008).</p> <ul style="list-style-type: none"> <li>• <b>Downstream boundary:</b> Estuary mouth (34° 5'31.98"S, 22° 8'55.43"E).</li> <li>• <b>Upstream boundary:</b> 34° 4'36.55"S, 22° 3'57.72"E/ 34° 2'4.54"S, 22° 8'2.91"E</li> <li>• <b>Lateral boundaries:</b> Estuary Functional Zone (5m contour above Mean Sea Level (MSL) along each bank)</li> </ul>
