Mouth Management Plan

Uilkraals Estuary

April 2018

Western Cape Estuary Management Framework and Implementation Strategy

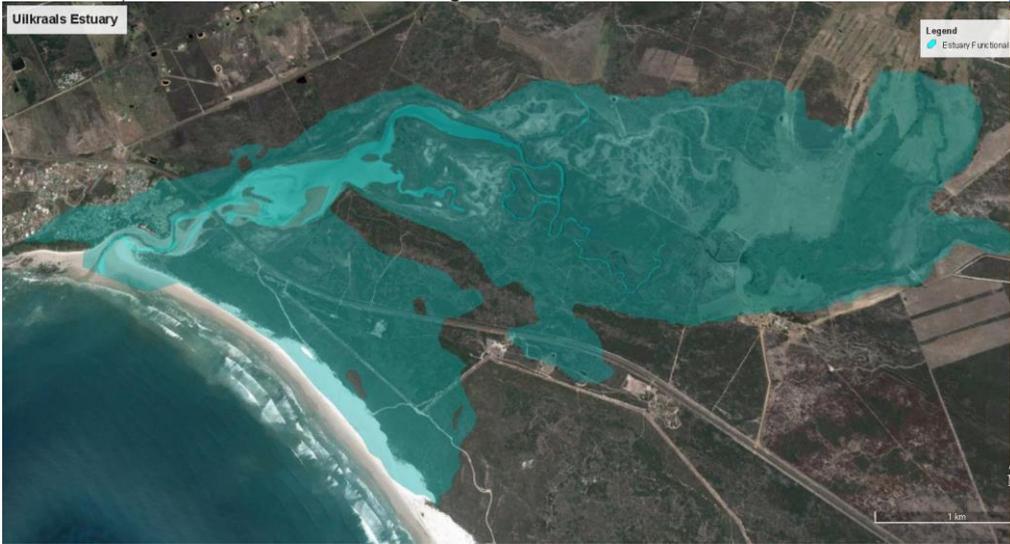
Threat	Discussion
<p>Location</p>	<p>The Uilkraals Estuary is situated approximately 60 km northwest of Cape Agulhas and 11 km east of Danger Point on the south-west coast within the cool temperate biogeographic region of South Africa. The geographical boundaries for the study are defined as follows (Clark et al. 2012):</p> <ul style="list-style-type: none"> • Downstream boundary: Estuary mouth 34°36'23"S, 19°24'33"E • Upstream boundary: 34°35'38.03"S, 19°28'0.05"E • Lateral boundaries: 5 m contour above Mean Sea Level (MSL) as depicted by the Estuary Functional Zone below in light blue.

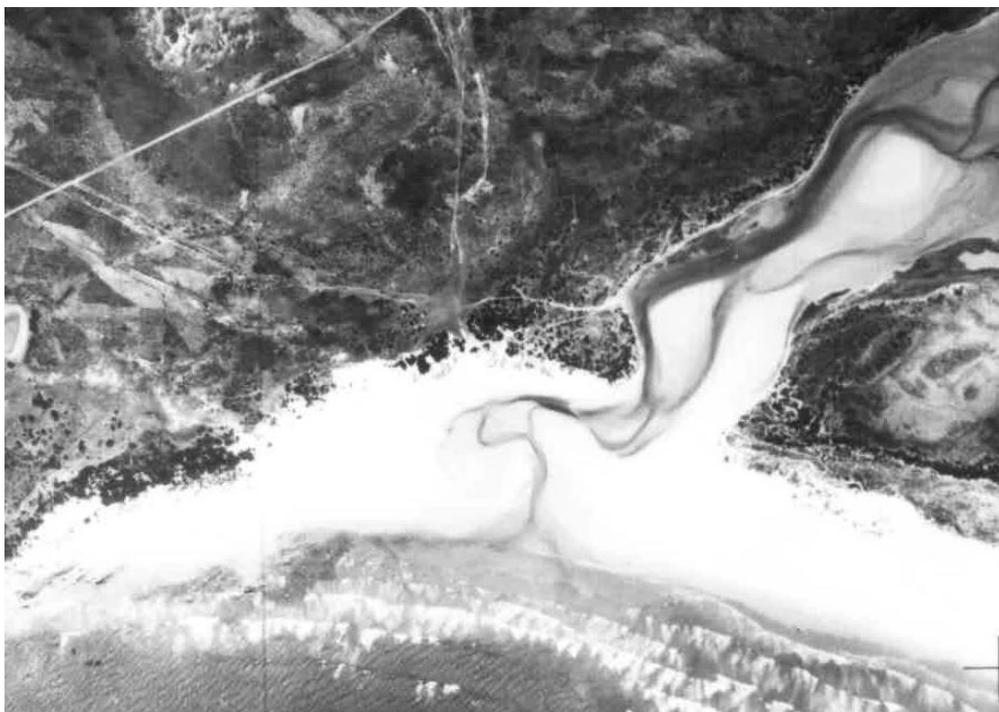
Figure 1: The Uilkraals Estuary in 1938 with open mouth and relatively deep meandering channels in the middle reaches

The Uilkraals mouth is relatively sheltered and measurements under taken by Ed Lucas and Sue Mathews indicate a berm height 1.91 to 1.98 m msl on 9 October 2010. All available historical aerial photographs of the Uilkraals Estuary show the mouth in an open state (Figure 1 to Figure 6).

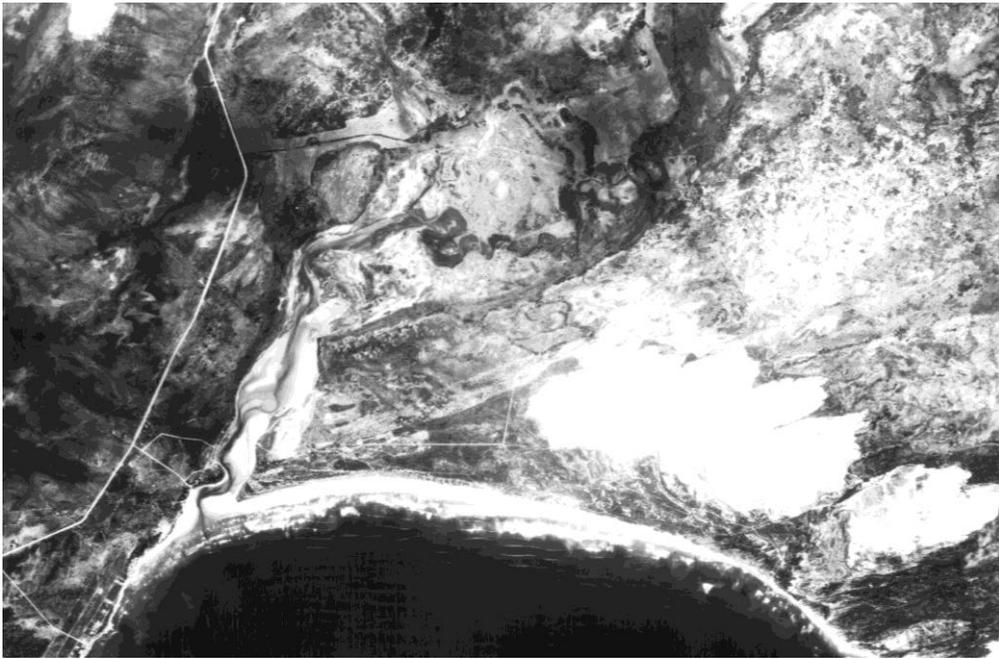
Figure 2: The Uilkraals Estuary in 1961 with open mouth and relatively deep meandering channels in middle reaches. Note open dune field on eastern side of system.

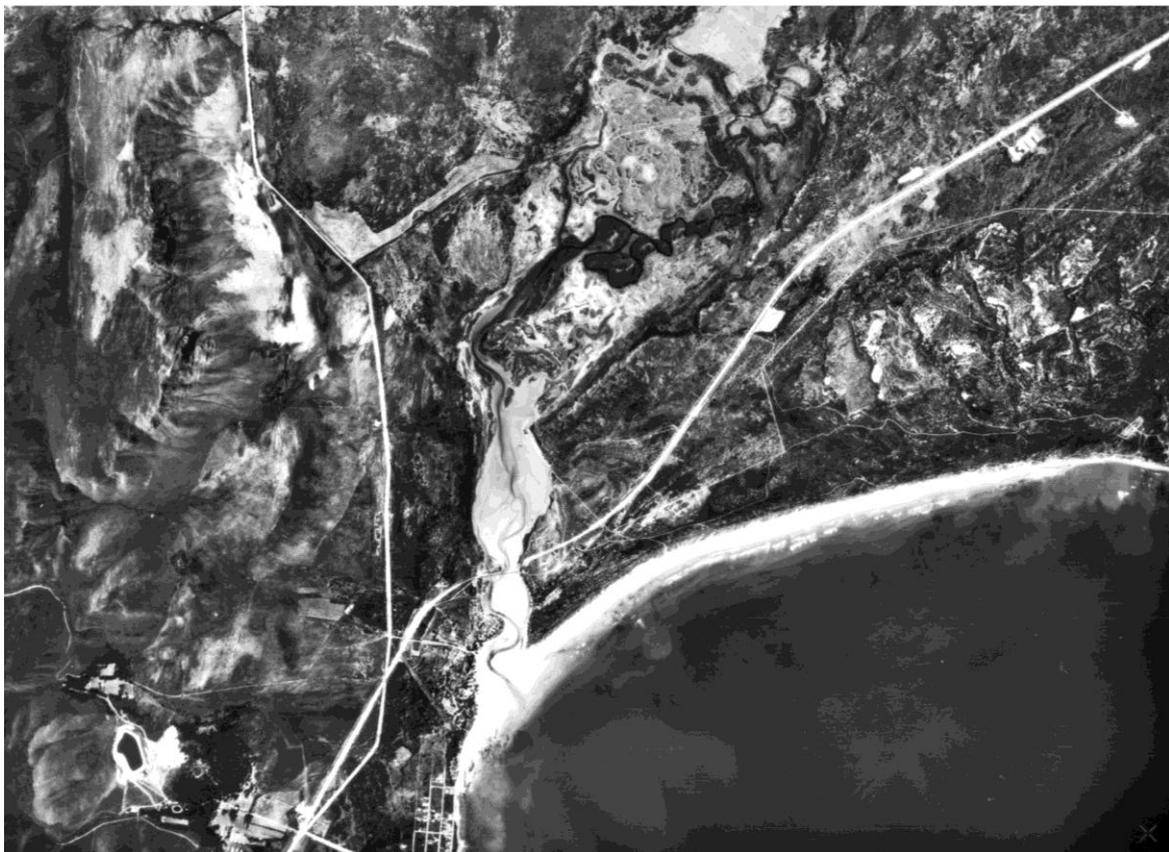
Figure 3: The Uilkraals Estuary in 1973 with open mouth. Note the road bridge over the middle reaches.

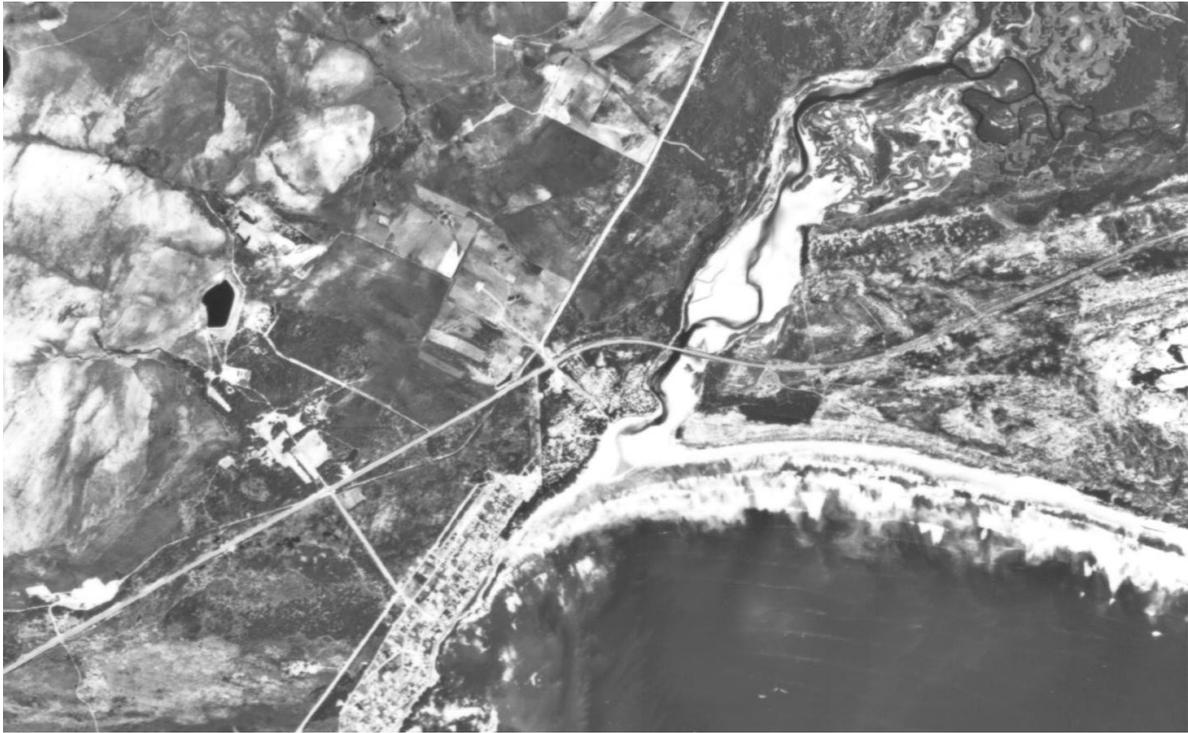
Figure 4: Uilkraals Estuary in 1990 with open mouth and relatively deep meandering channels in the middle reaches

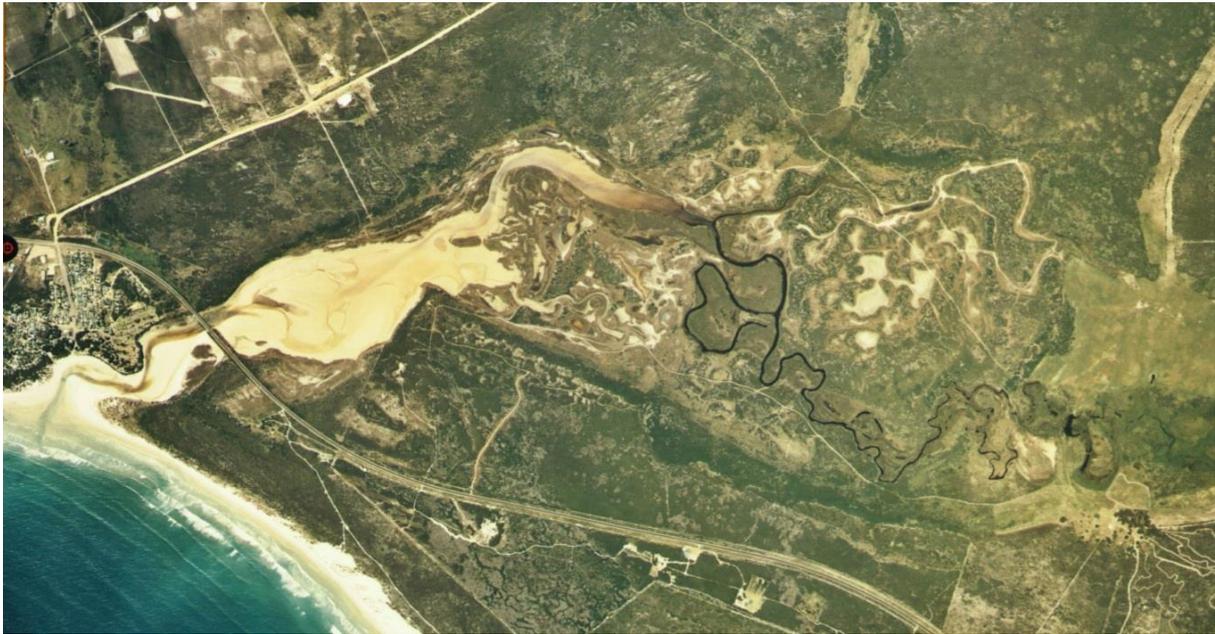
Figure 5: The Uilkraals Estuary on November 2005 with open mouth and relatively shallow meandering channels in the middle reaches.

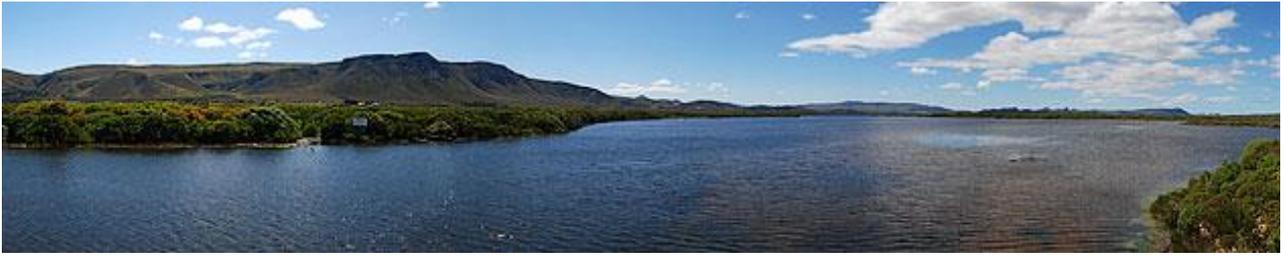
2011 Closed mouth with extensive inundation of intertidal and flood plain area (Source: S Mathews)

Figure 6: Photographic record of water levels in the Uilkraals Estuary during the closed state.

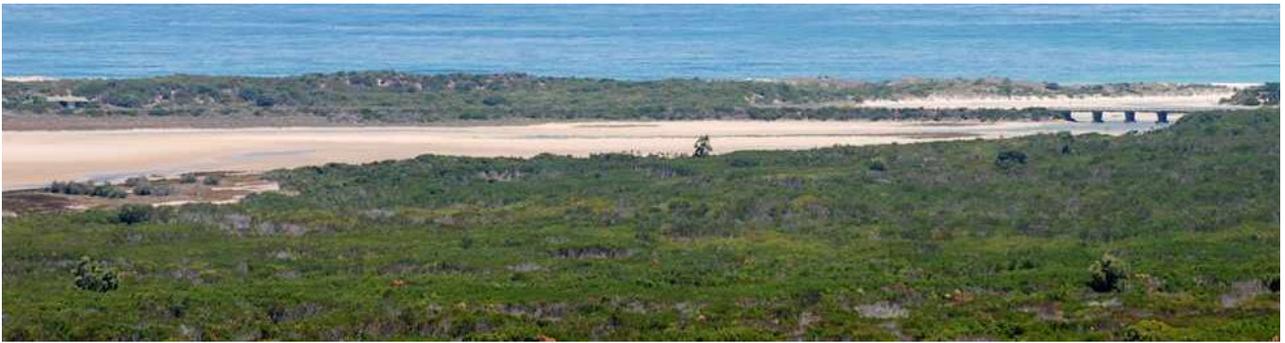
2012 Closed mouth with low water levels due to evaporation (Source: S Mathews)

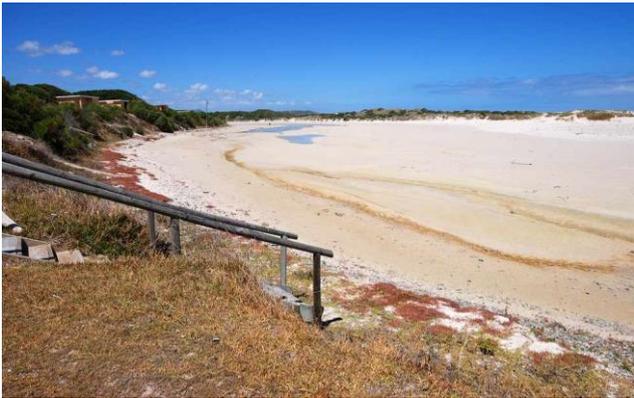
2012 Closed mouth and exposed in mouth region (Source: S Mathews)

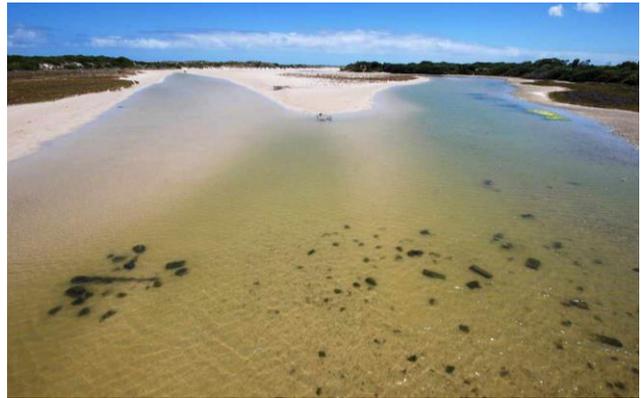
2012 Closed mouth and exposed downstream from bridge (Source: S Mathews)

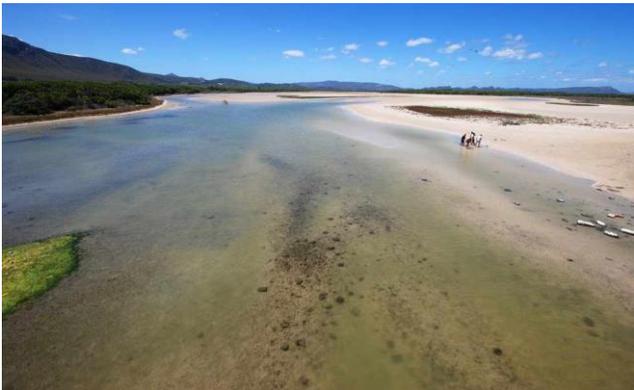
2012 Closed mouth and exposed up-stream from bridge (Source: S Mathews)

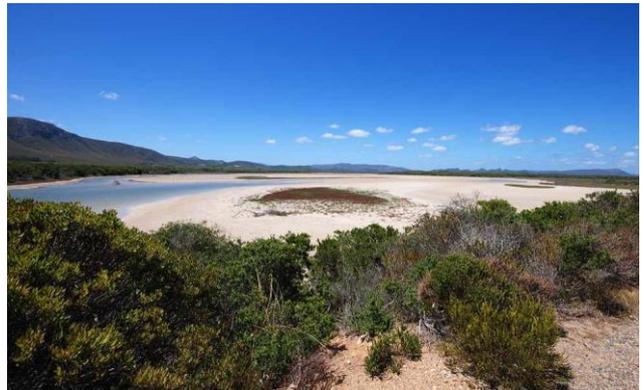
2012 Closed mouth and exposed in upper reaches (Source: S Mathews)

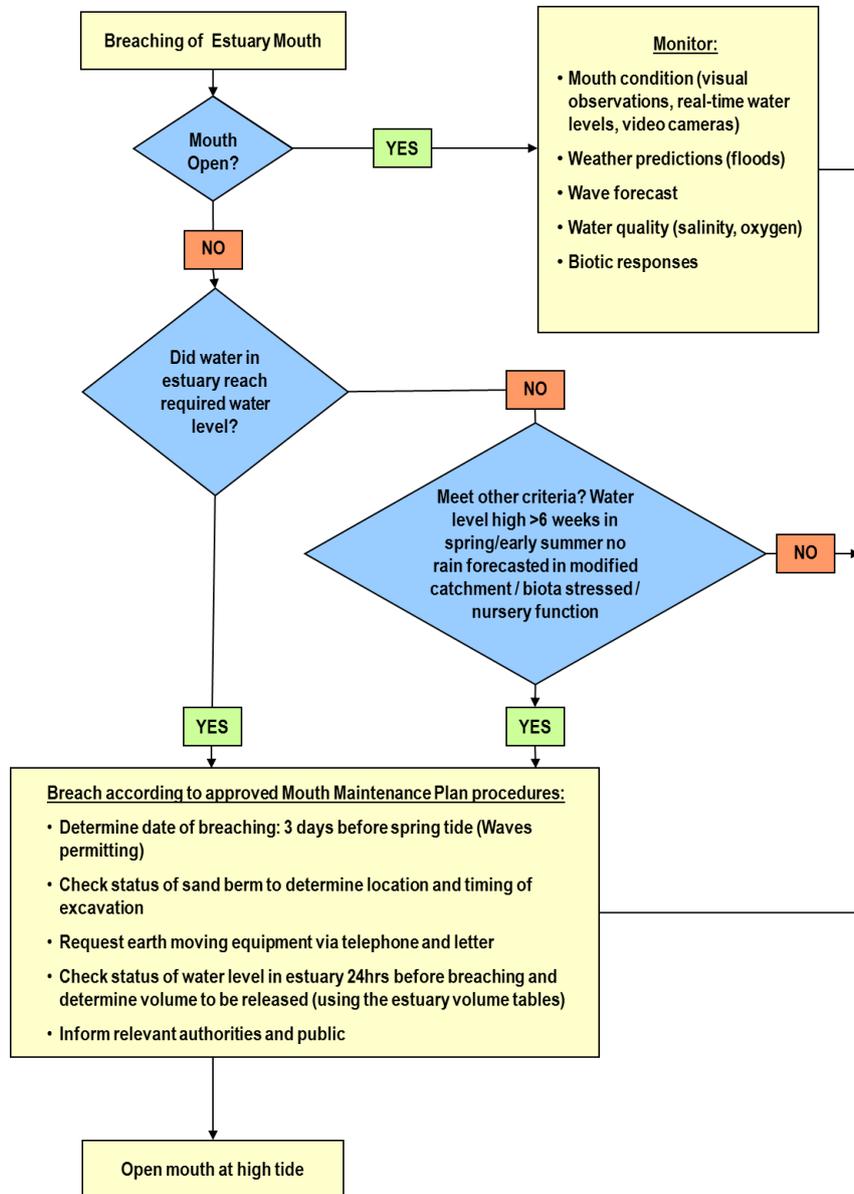
Figure 7: A flow chart illustrating the breaching plan for normal conditions

committee is tasked with executing the approved MMP, it should be recognized that an estuary mouth is highly dynamic and unforeseen events may require special management actions. In such an event, additional verbal (followed by written) authorisation may be required from the authorising authority (i.e. DEA&DP) which needs to be supported by specialist comment and suggestions.). A flow chart for a planned mouth breaching procedures to be followed by the breaching committee is included in Figure 7.

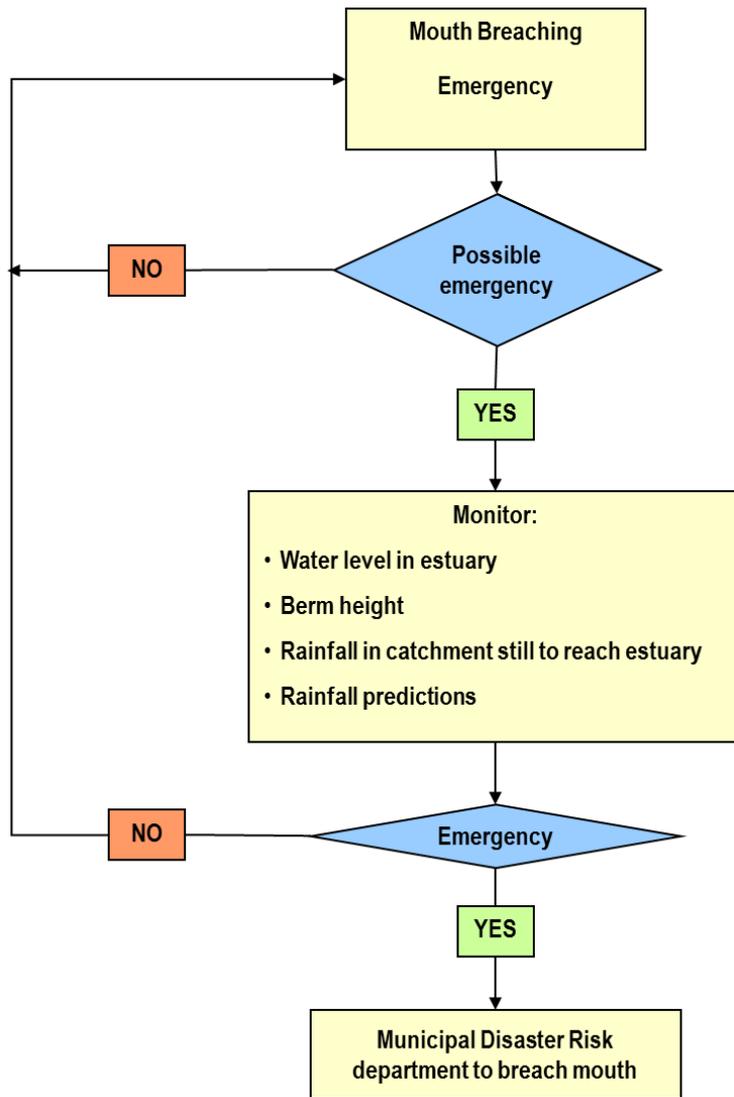
Figure 8: A flow chart illustrating the breaching plan for emergency conditions

A flow chart for the undertaking of mouth breachings under emergency conditions is included in Figure 8. Breachings should be undertaken in the swiftest manner possible and in most cases the Disaster Management Department of the local municipality is responsible. While breaching should be conducted according to an Estuary Mouth Management Plan and an approved Mouth Maintenance Management Plan, some of the general breaching principles may be waived under emergency conditions to ensure an expedient breaching.
