BANK EROSION IN THE BERG RIVER ESTUARY

Causes and Concerns

February 2021

Anchor Research & Monitoring (Pty) Ltd
in association with Zutari

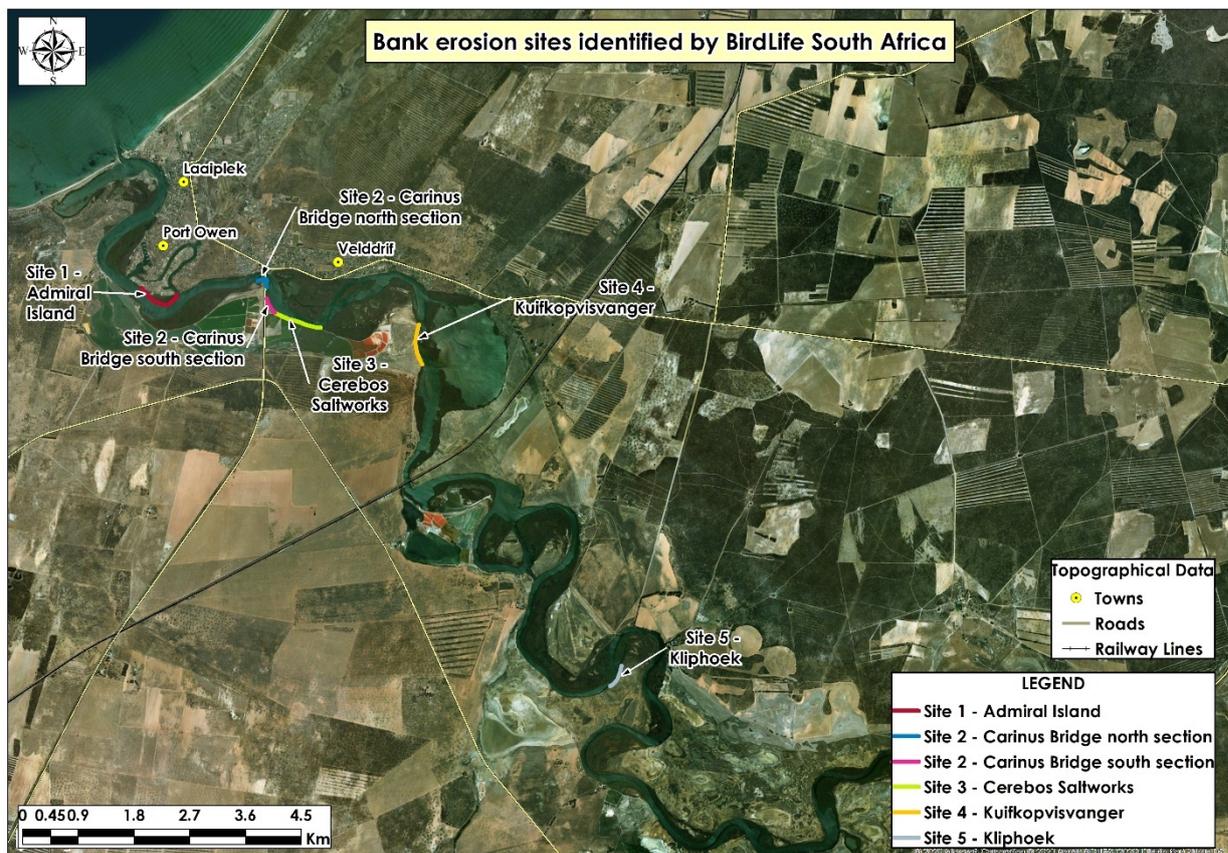
BirdLife South Africa (Murison, pers. comm.) identified five areas where bank erosion is occurring that were of concern because of rapid bank loss that had been observed and because it was suggested that the sites might encompass a wide range of underlying causes driving bank erosion. These are at Kliphoek, Kuifkopvisvanger, Cerebos Saltworks, Carinus Bridge and Admiral Island.

Figure 20: The five bank erosion sites that were short listed by BirdLife South Africa (Murison, pers. comm.)

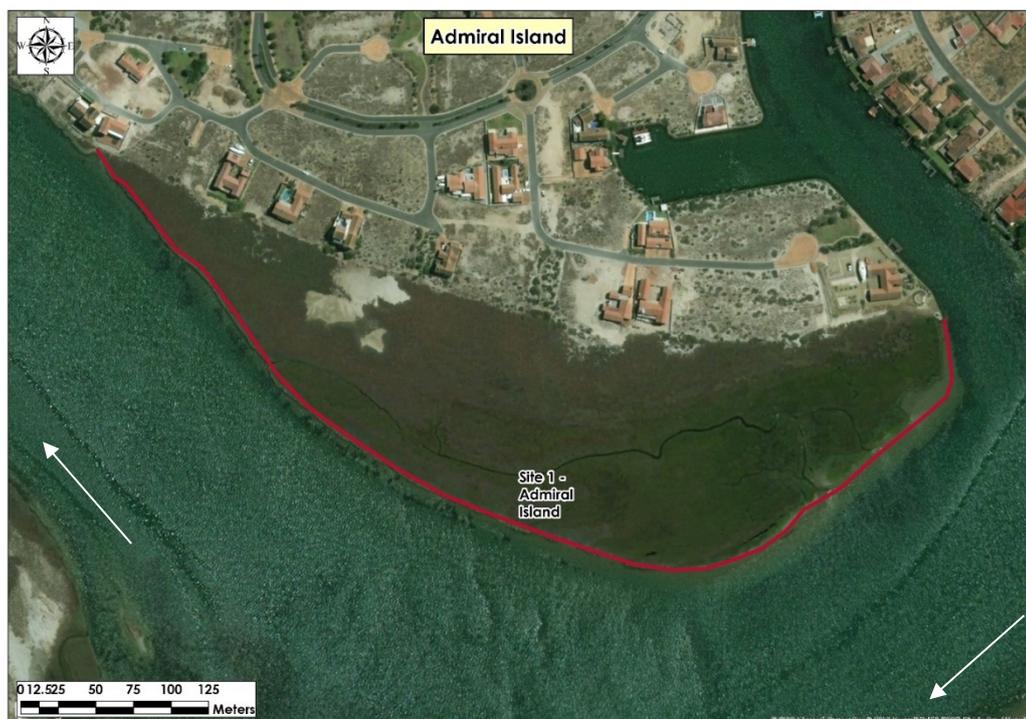
The residents at Admiral Island blame wind waves for most of the erosion, stating that winds in excess of 20 km/h or 11 knots are to blame (Murison, pers. comm.). Winds at this velocity or greater occur for 16 % to 17% of the time from the south, based on wind data at Langebaanweg located some 20 km to the south (**Figure 49**).

Considering the position of the salt marsh, which is predominantly on the inside of a bend, it is likely that the main cause of erosion is from waves and not from flow as this should be in an area of sediment deposition due to flow. The bank is exposed to winds from the south and is also in a section of the channel which gets frequent boat traffic, lying between Port Owen and the mouth and it is likely that waves are the dominant cause of erosion at this site. **Figure 22** shows the effects of boat waves on the bank.

Figure 21: Site 1: Admiral Island. The arrows show the flow direction

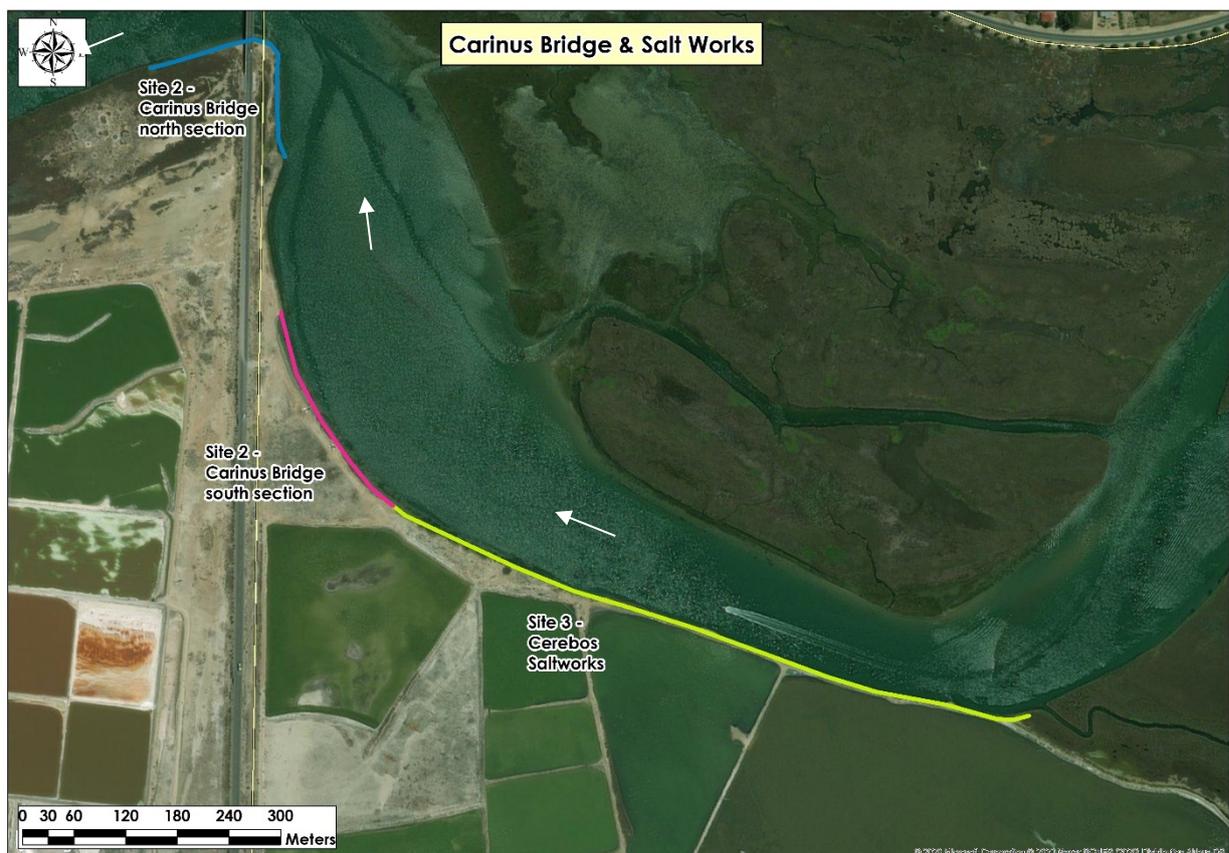
Erosion here could be due to flow, being located on the outside of a bend, and wind and boat waves. On the day of the site visit the bank was visibly eroding due to wind waves during a strong southeaster, with cloudy water along the bank caused by suspension of fines from the bank.

The location of the erosion problem upstream of Carinus Bridge, on the outside of a bend, suggests that flow is playing a significant part in the erosion of the bank. It is likely that the bank erosion at Carinus Bridge is part of a long-term natural process where the channel is migrating laterally over time to the west, as typically occurs in alluvial meandering rivers. Stabilisation of the bank should then be informed by the value of the habitat that is potentially being lost but also in the context of limitation of damage to the road embankment and bridge, especially in the context of the reduced habitat in the estuary due to anthropogenic development. New habitat may be forming on the opposite bank as the channel moves southwestward. Considering the proximity of the bank location to the road embankment, there isn't much more room for the river before it starts to threaten the integrity of the road embankment.

Figure 24: Areas with bank erosion at Carinus Bridge and the saltworks. The north and south sections at Carinus Bridge are shown by the blue and pink lines respectively. The section between the pink and blue lines is where the existing riprap protection exists. The white arrows indicate the flow direction

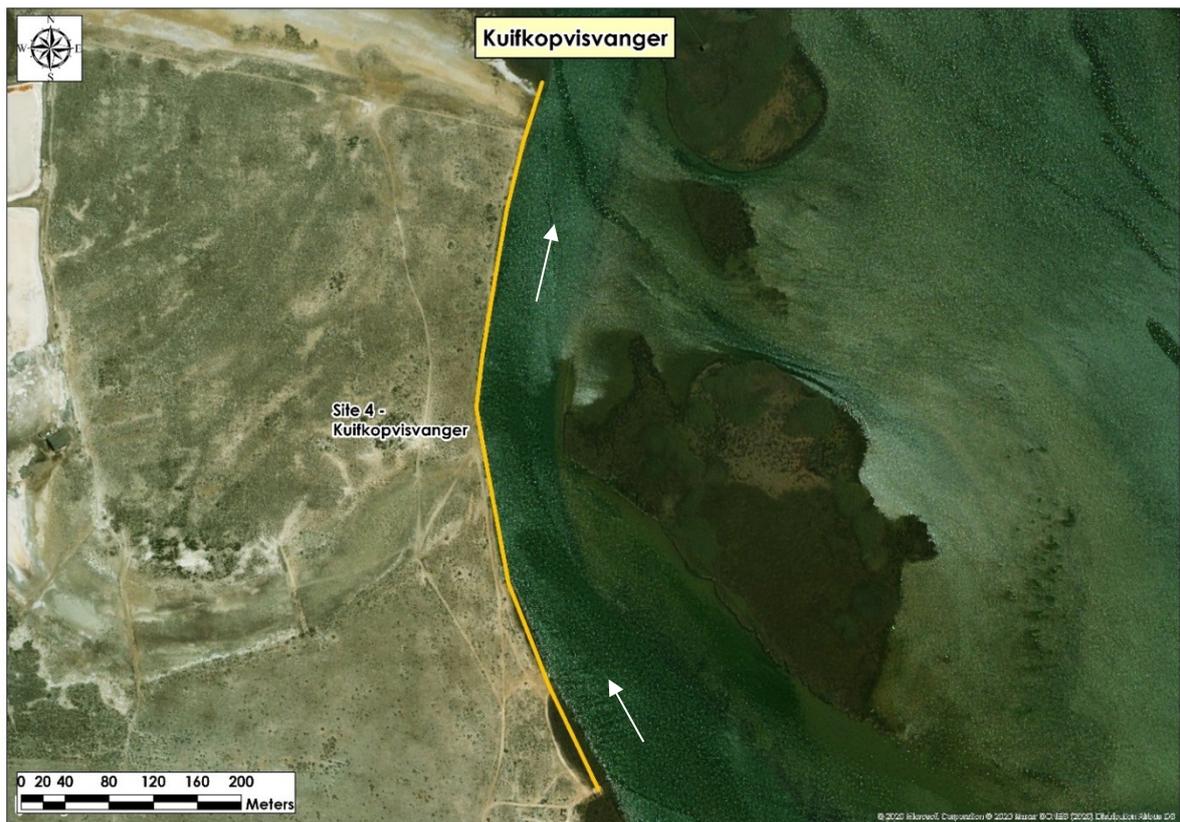
The Kuifkopvisvanger site (**Figure 20**) is located on the outside of a bend downstream of the Transnet Sishen Saldanha railway bridge. The section of bank that is eroding is approximately 675 m long. The bank is very steep and is collapsing into the channel. The landowner has attempted to prevent further erosion by dumping rubble along the bank. This is not only unsightly but also is not very effective.

The bank is located on the outside of a bend and hence it is expected that the erosion is at least to some extent caused by flow during flood events. The channel runs in a south to north direction here and hence is aligned to the summer wind direction, allowing for a long fetch and hence wind wave erosion may be a contributor in addition to boat waves and flow related erosion.

The location of the erosion problem, on the outside of a bend, suggests that flow is playing a significant part in the erosion of the bank. It is likely that the bank erosion at Kuifkopvisvanger is part of a long-term natural process where the channel is migrating laterally over time towards the west, as typically occurs in alluvial meandering rivers. Stabilisation of the bank should then be informed by the value of the habitat that is potentially being lost, especially in the context of the reduced habitat in the estuary due to anthropogenic development. New habitat may be forming on the opposite bank as the channel moves westward.

Figure 32: Site 4: Kuifkopvisvanger. The arrow indicates the flow direction

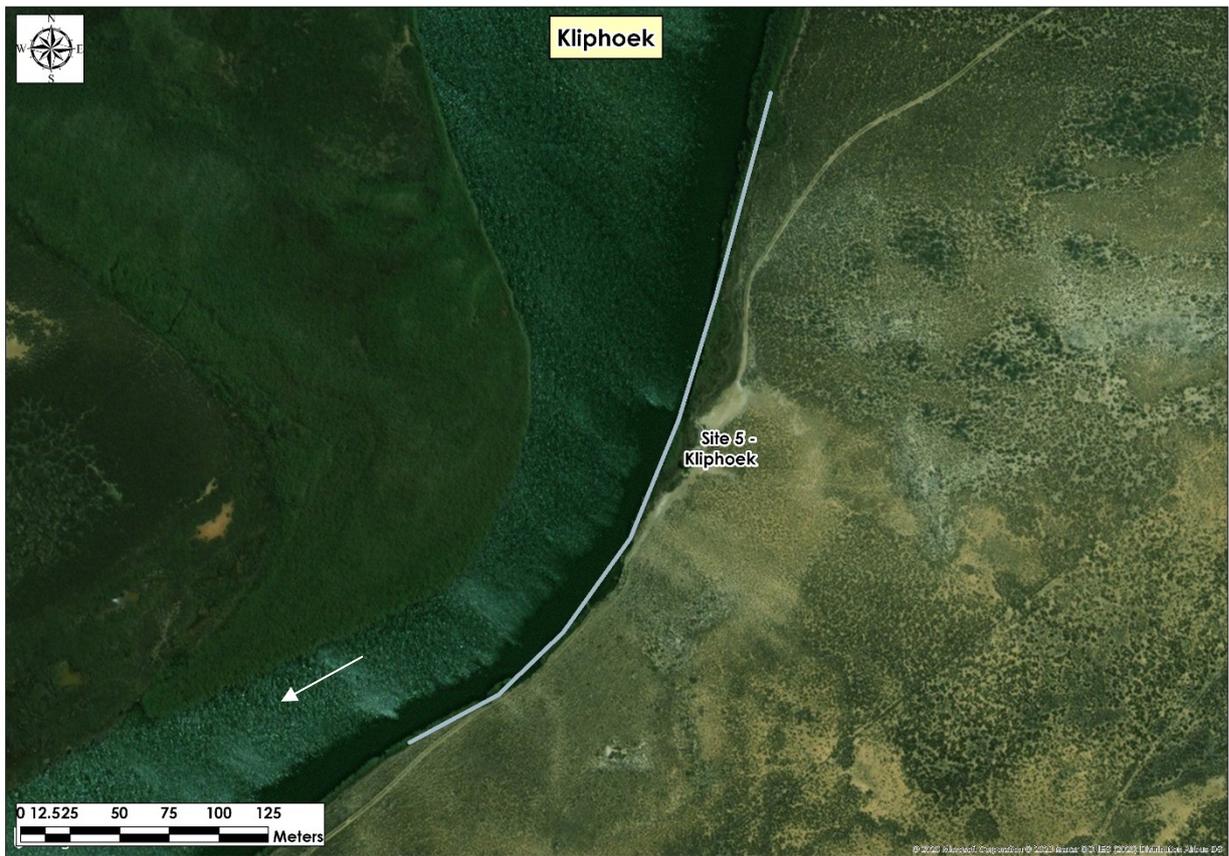
The Kliphoek site (**Figure 20**) is located on the outside of a bend in a meander upstream of Kliphoek. The bank erosion at Kliphoek extends over a distance of approximately 400 m, where the bank has been undercut and is progressively eroding back. There is an additional section downstream of at least 300 m length where there has been bank erosion but a strip of reeds has grown which is protecting the bank from further erosion. These are shown in the figures below.

Considering the orientation of the bank, wind wave erosion may only be caused by wind from the southwest, west or northwest. The wind rose for Langebaanweg (**Figure 49**) suggests that winds in this area blow from the southwest for significant periods. It is likely that the erosion here is caused by flow, wind and possibly boat waves. Boats are visible in this reach in some of the photographs.

The location of the erosion problem, on the outside of a bend, suggests that flow is playing a significant part in the erosion of the bank. It is likely that the bank erosion at Kliphoek is part of a long-term natural process where the channel is migrating laterally over time to the southeast, as typically occurs in alluvial meandering rivers. Stabilisation of the bank should then be informed by the value of the habitat that is potentially being lost, especially in the context of the reduced habitat in the estuary due to anthropogenic development. New habitat may be forming on the opposite bank as the channel moves southeastward.

Figure 37: The Kliphoek site. The arrow shows the flow direction. Waves visible in the photo suggest that the wind was blowing from the south and that the south bank was relatively calm at the time of the photograph

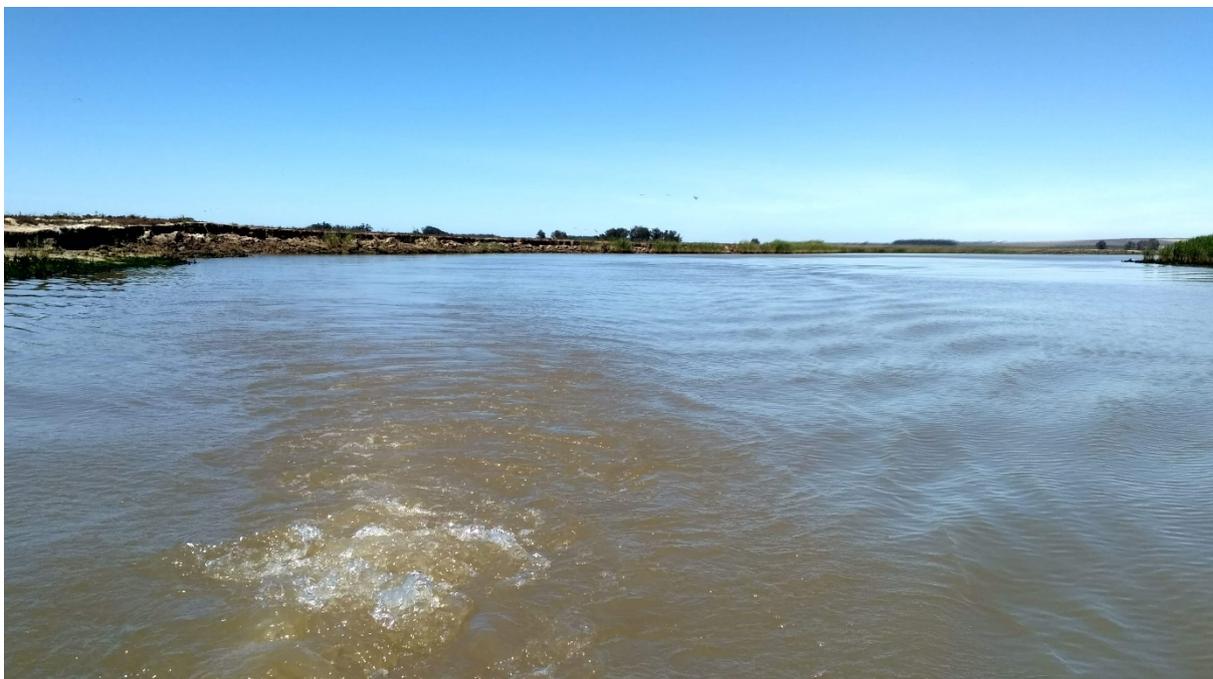
Figure 38: View of most of the Kliphoek bank erosion site from upstream. (Photo: Martin Kleynhans)

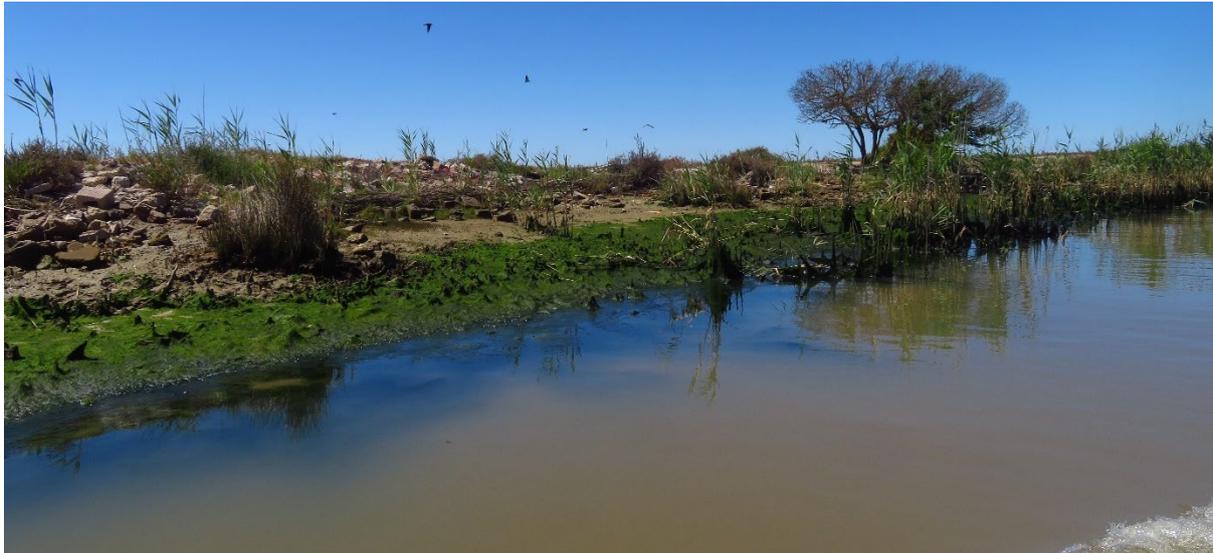
Figure 39: A stable section of the bank at Kliphoek. (Photo: Martin Kleynhans)

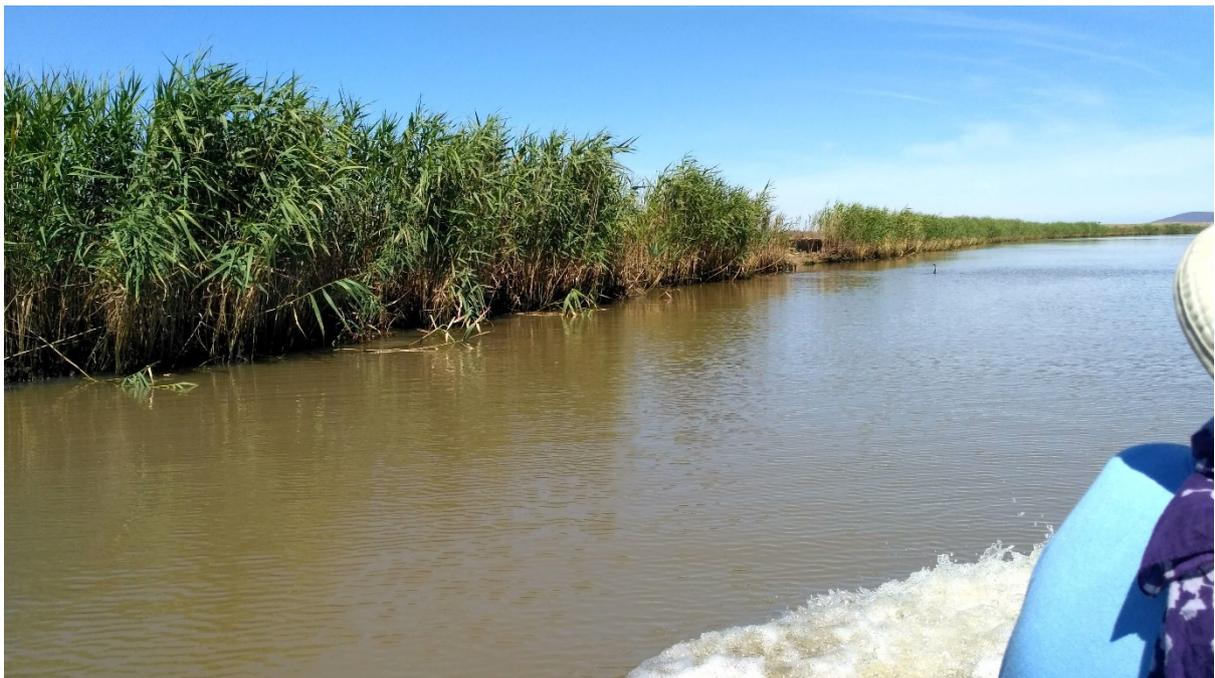
Figure 43: Reeds stabilizing the bank downstream of Kliphoek. (Photo: Martin Kleynhans)

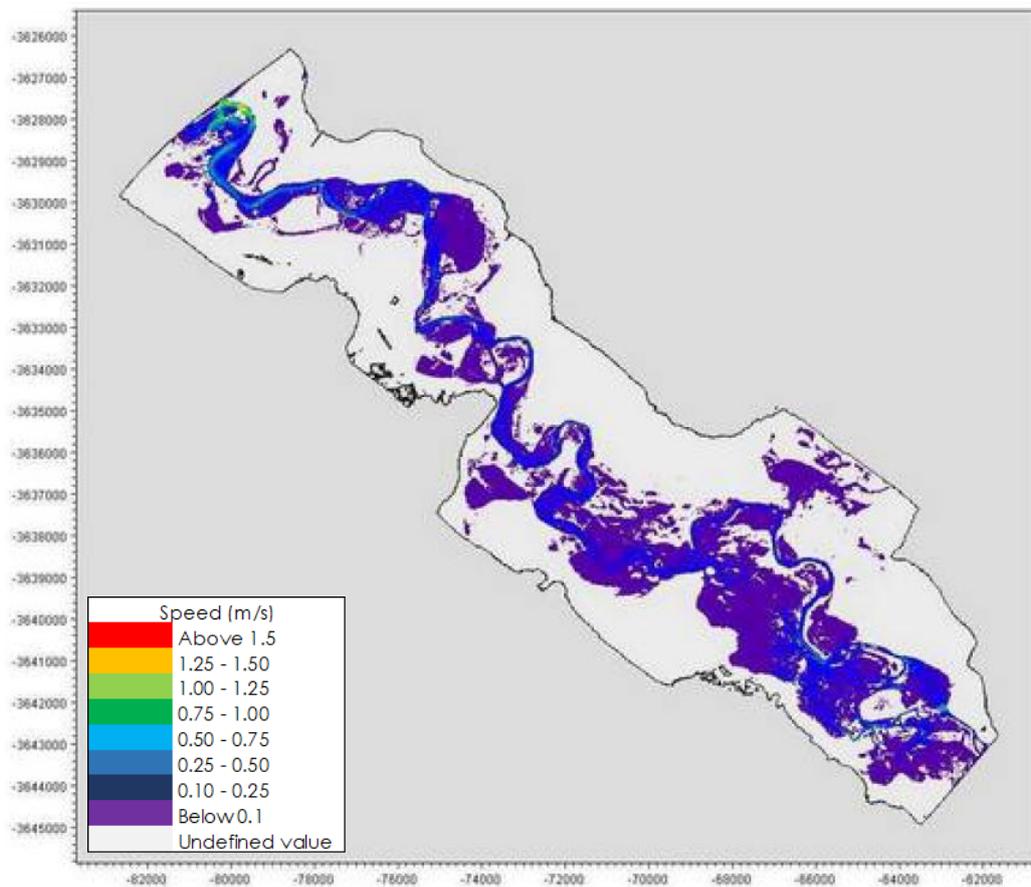
They also modelled various flood events passing through the estuary and the velocities for a large flood event are shown in **Figure 48**. They noted that the model predicted that the channel would scour towards the banks and deposit towards the channel centre. The model also predicted this to occur in the upper reaches near Kersefontein and in the lower reaches near the mouth, however Beck and Basson only discussed the impacts on the upper estuary.

The modelling of Beck and Basson (2004) suggests that at least some of the bank erosion is caused by flow during flood events. The sites at Kliphhoek, Kuifkopvisvanger, Cerebos Saltworks and Carinus Bridge are all located on the outside of bends and this is where erosion due to flow would be expected to occur.

Figure 48: Maximum velocities during a flood of 890 m³/s (Beck & Basson, 2004)

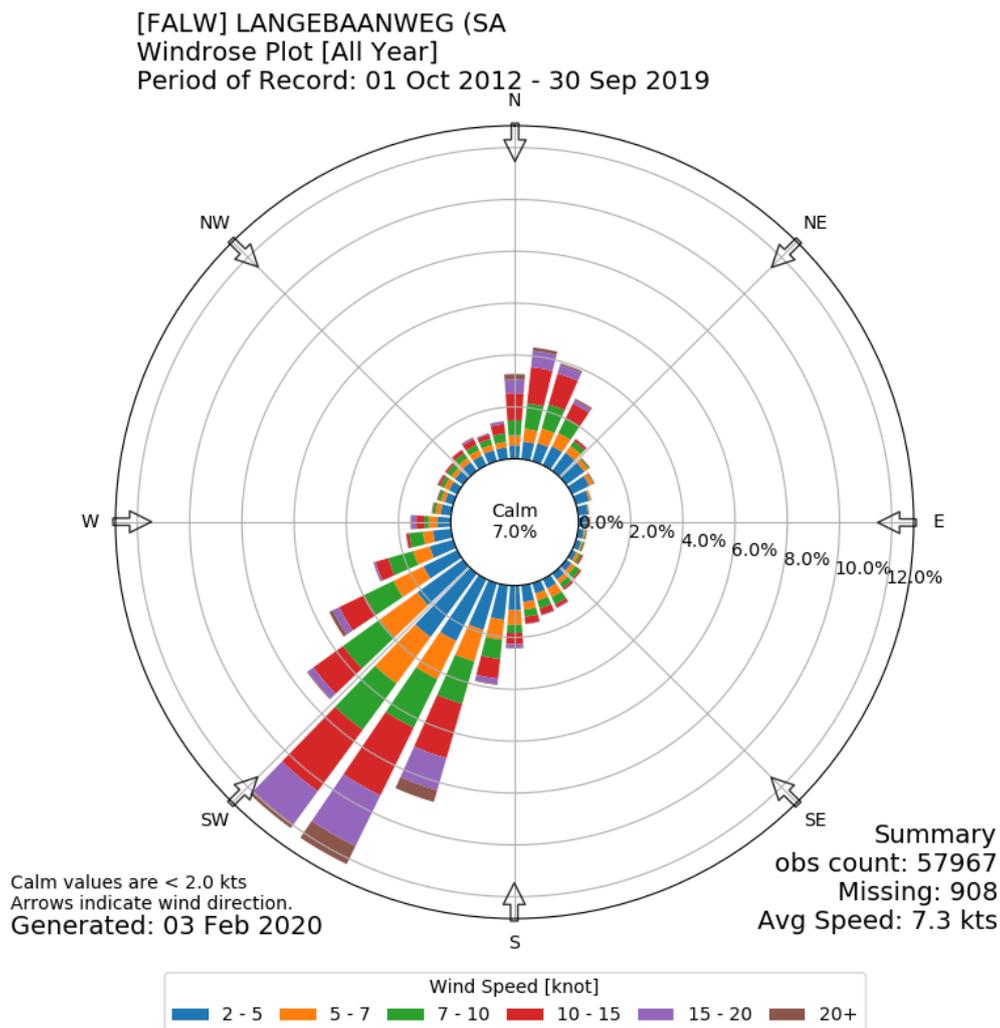
A significant cause of erosion appears to be due to waves caused by wind and boats. The wind rose shown in **Figure 49** is for Langebaanweg, located some 15 to 20 km to the south of the Berg River Estuary and shows that the predominant wind directions are from the southwest (mostly summer) and the northeast (mostly winter). Winds from the southwest occurred for approximately 40% of the time and 5% of the time wind blew from this general direction with a strength in excess of 15 knots (approximately 28 km/h). Thus, wind erosion would be expected to occur on banks where the river is aligned in a southwest - northeast direction to achieve a long fetch length, or on banks that are on the northeast side of the channel opposite an area of open water.

Figure 49: Wind rose for Langebaanweg airforce base, located some 15 to 20 km south of the Berg River Estuary. Wind speeds are annual and were obtained on 3 February 2020. (IEM and NOAA, 2020)

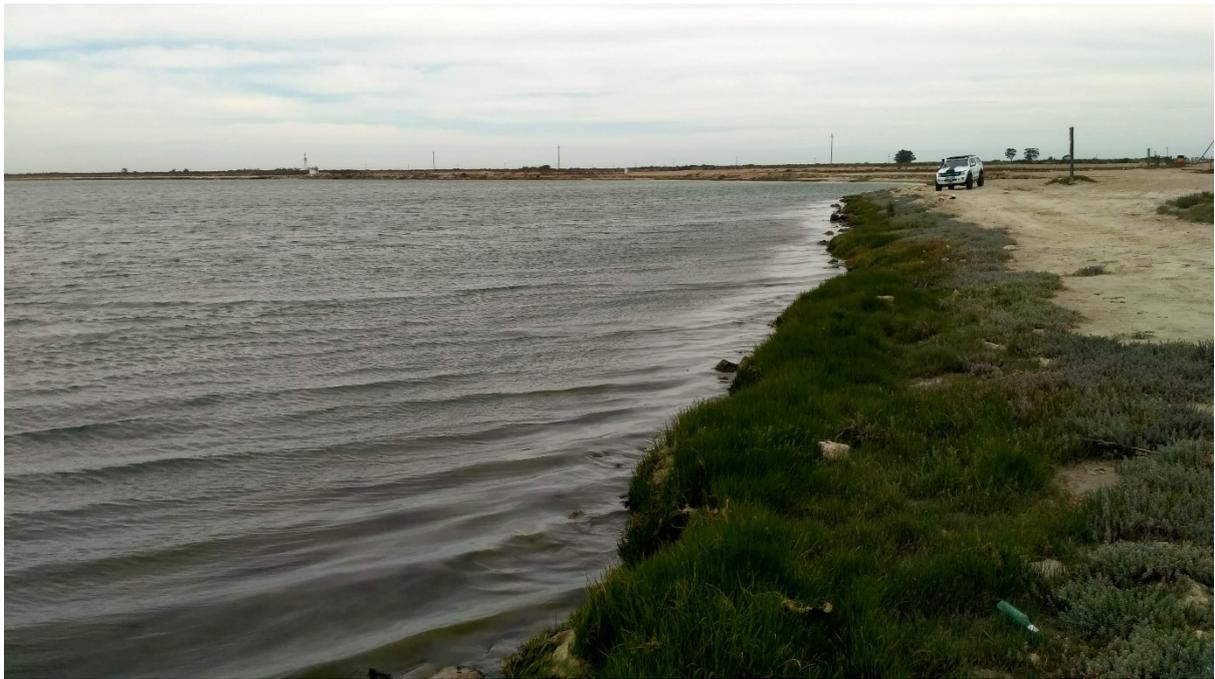
erosion protection is performing very well and has not only prevented quite serious bank retreat (**Figure 55**), when the rest of the bank is compared to the section protected by the riprap, but also that the riprap has revegetated and is providing habitat as well. The channel is about 3.6 m deep here according to the survey of 2003 (**Figure 7**) and the riprap extends to a depth near the base of the channel, hence a large volume of riprap was required for this revetment.

Figure 56: The riprap at Carinus Bridge having revegetated successfully. Photo looking upstream. (Photo: Martin Kleynhans)

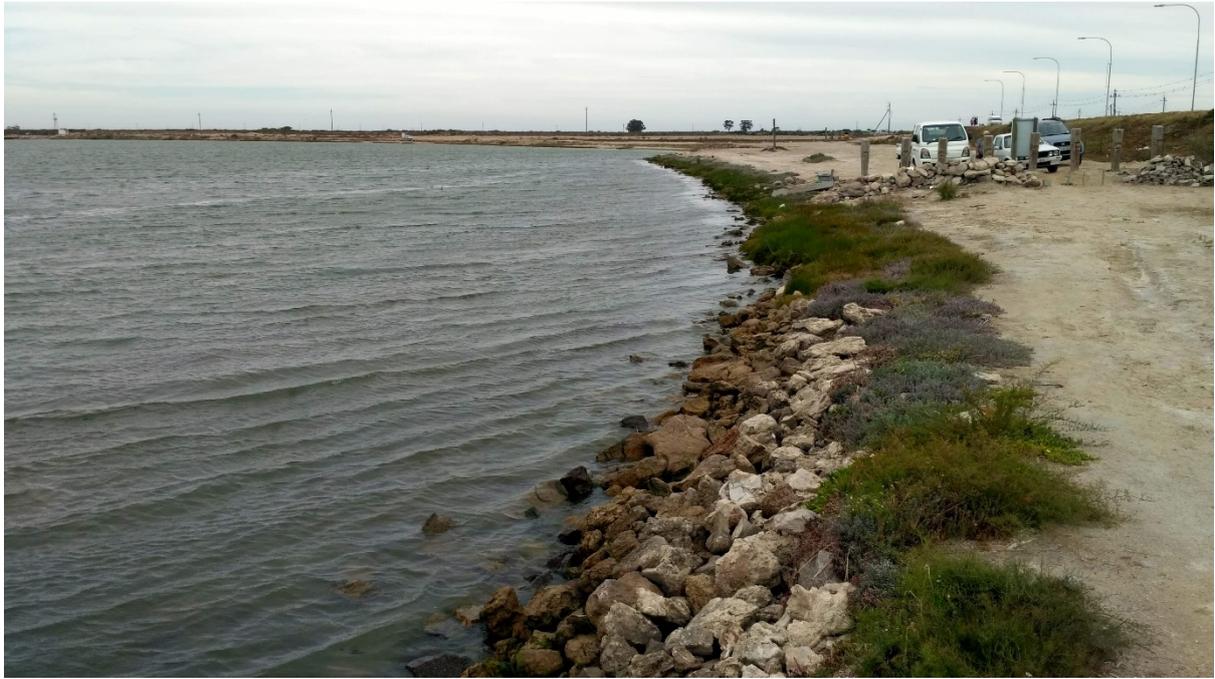
Figure 58: The Carinus Bridge riprap looking upstream from near the downstream end. (Photo: Martin Kleynhans)
