# **Mouth Management Plan for the Piesang River estuary**

October 2019

Western Cape Estuary Management Framework and Implementation Strategy

Western Cape Government, Department of Environmental Affairs & Development Planning

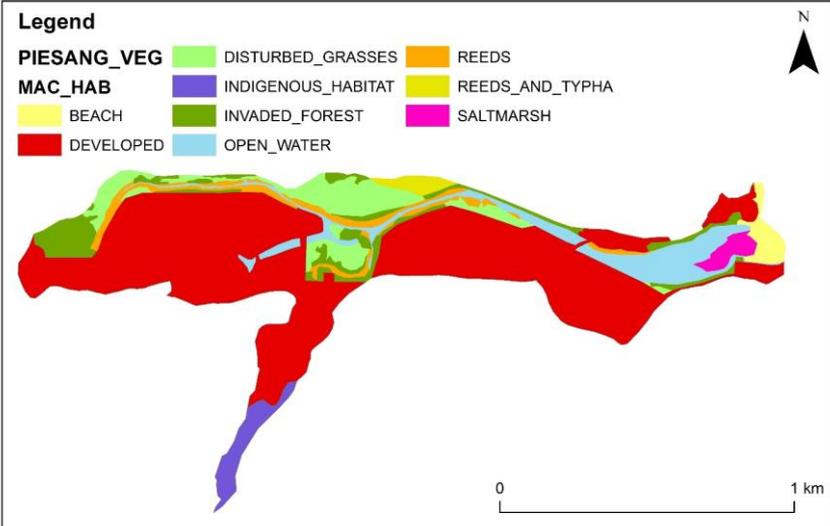
<p><b>Figure 1: Distribution of macrophyte habitats at the Piesang River estuary based on 2013 aerial photographs and field surveys in June 2016.</b></p>

Threat	Discussion
<p><b>Important vegetation</b></p>	<p>Little natural riparian habitat remains at the Piesang River estuary due to recreational and residential development and the stabilising/reclaiming of the estuary banks. Invasive plants are extensive in the valley and the remaining forest habitat has been damaged by roads and tracks around the estuary. There is some potential to rehabilitate sections of the Piesang River at the Roodefontein Golf Estate and in the upper catchment.</p> <p>Common reed <i>Phragmites australis</i> fringe the open water in the middle and upper reaches. Reeds and <i>Typha capensis</i> occur in a wetland area on the north bank. Some sedges, <i>Cyperus laevigatus</i> and <i>Cyperus textilis</i>, fringe this habitat. <i>Triglochin elongata</i> occurs in the undergrowth of the reeds in the middle reaches opposite the townhouses above the Beacon Isle Drive bridge. <i>Juncus kraussii</i>, <i>Cyperus laevigatus</i> and <i>Cyperus textilis</i> occurs on the north bank in the recreational area above the Beacon Isle Drive bridge. The sedge <i>Eleocharis limosa</i> is present in the lower reaches of the estuary on the sheltered muddy south bank below the bridge. While a small area of <i>Sarcocornia natalensis</i> subsp. <i>natalensis</i> and <i>Bassia diffusa</i> salt marsh occurs in the lower reaches of the estuary. These saltmarshes die back during periods of mouth closure. At higher elevations <i>Sporobolus virginicus</i> covers the sand. Eelgrass <i>Zostera capensis</i> has also been recorded in the estuary in the past indicating that the estuary opens regularly and experiences tidal exchange (Adams and Bornman 2007).</p>

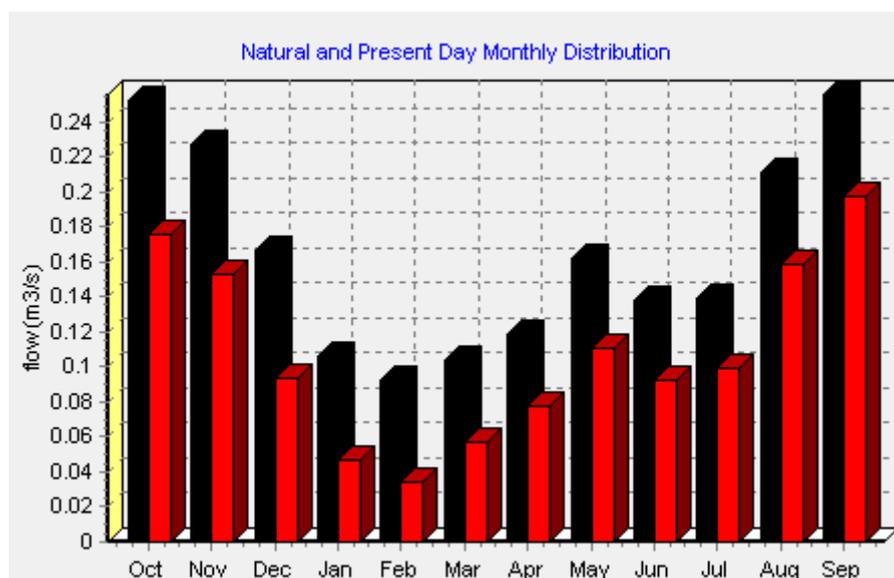
**Figure 2: Piesang River estuary: Natural (black) and Present (red) monthly flow distribution showing a significant decrease in river inflow to the estuary in the low flow periods (Van Niekerk et al. 2015).**

The catchment of the Piesang River estuary is estimated at about 35 km<sup>2</sup> with a total river length of about 17 km (Duvenhage and Morant 1984). The Piesang catchment receives rainfall throughout the year, with peaks in autumn and spring. The mean annual runoff (MAR) to the Piesang River estuary was estimated at about 5.2 x 10<sup>6</sup> m<sup>3</sup> under natural condition (Table 2 & Figure 2). This has been reduced by 34% to about 3.4 x 10<sup>6</sup> m<sup>3</sup> under the Present State (DWS 2015). A broad assessment of the changes in runoff to the estuary shows both a reduction in low and high flow months with a related increase in the low flow period.

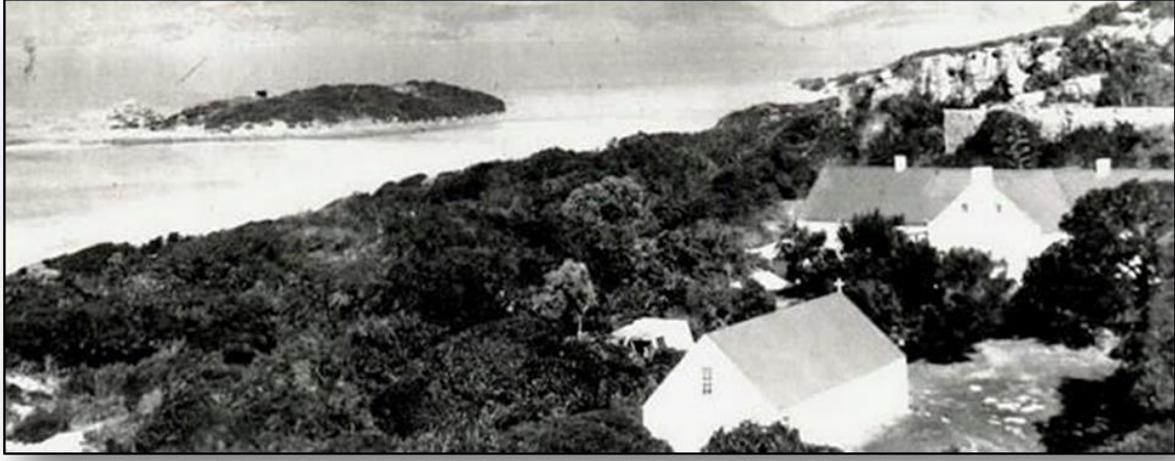
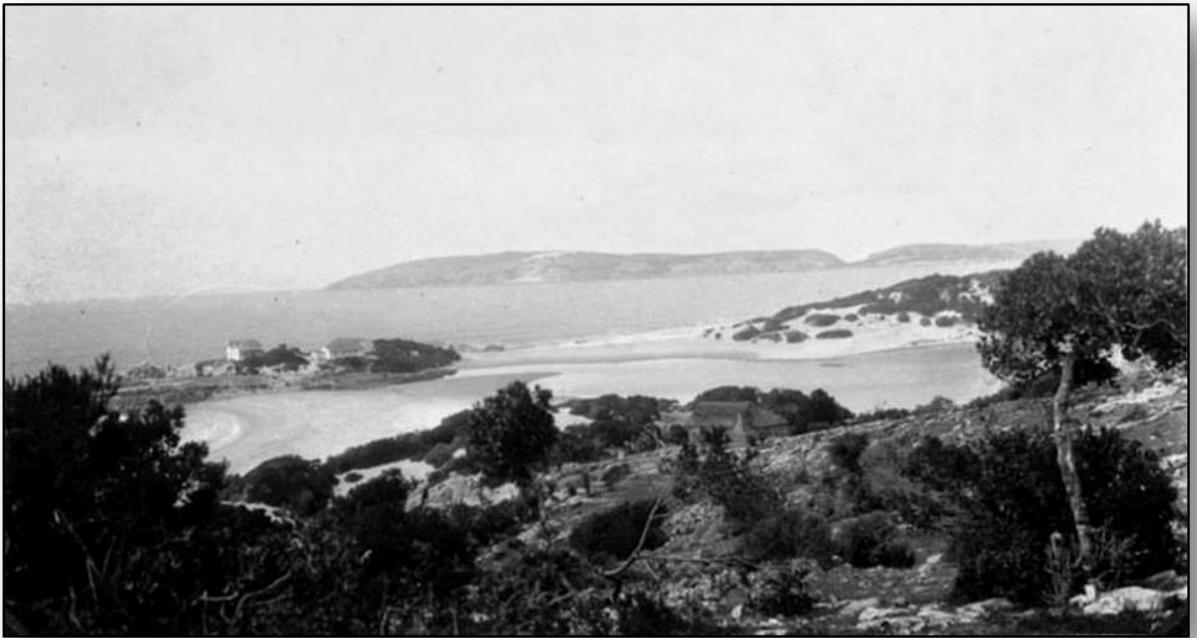
**Figure 3: Historical photographs of the Beacon Island before there was any significant development (circa 1930).**

Historical imagery show that the Piesang River estuary channel meandered across the lower reaches of the system in extensive s-curves. Looking at the pre-development photographs, it is highly likely that the estuary outlet could have mouthed out either side of the Beacon Island and that it often was a real island (Figure 3, Figure 4 and Figure 5). The road and other developments connecting Beacon Isle now constrain the estuary mouth to opening on Central beach (Figure 6). These historical images also show a large open water area in the lower estuary near the mouth. Also evident from these images is the fact that the estuary was a predominantly open system in contrast with the photograph taken during February 2018 showing a very small open water area Figure 6.

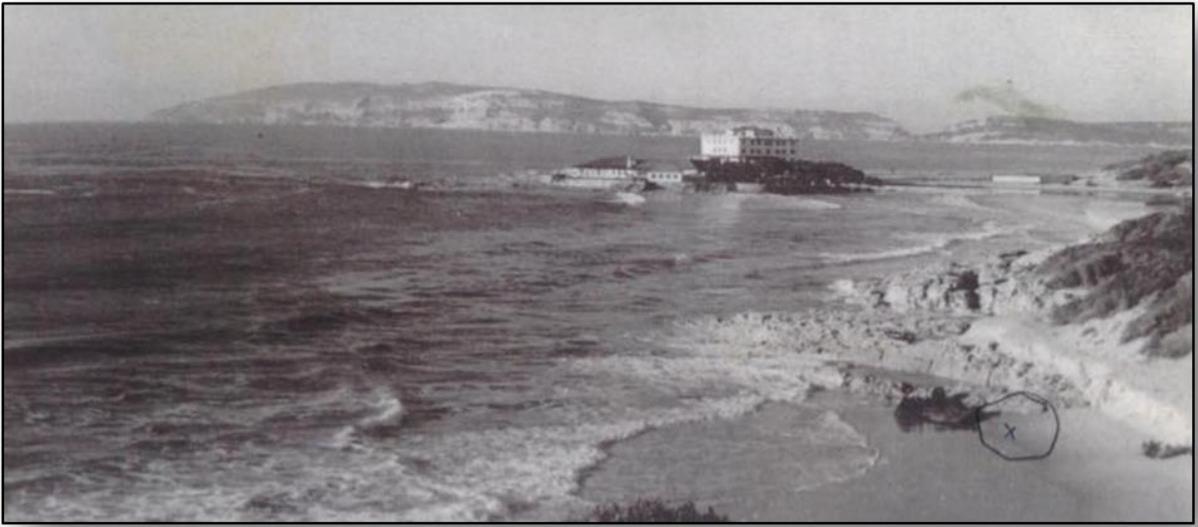
**Figure 4: The Piesang River estuary mouth after significant sea storm in 1942 which removed most marine sediment from Middle beach.**

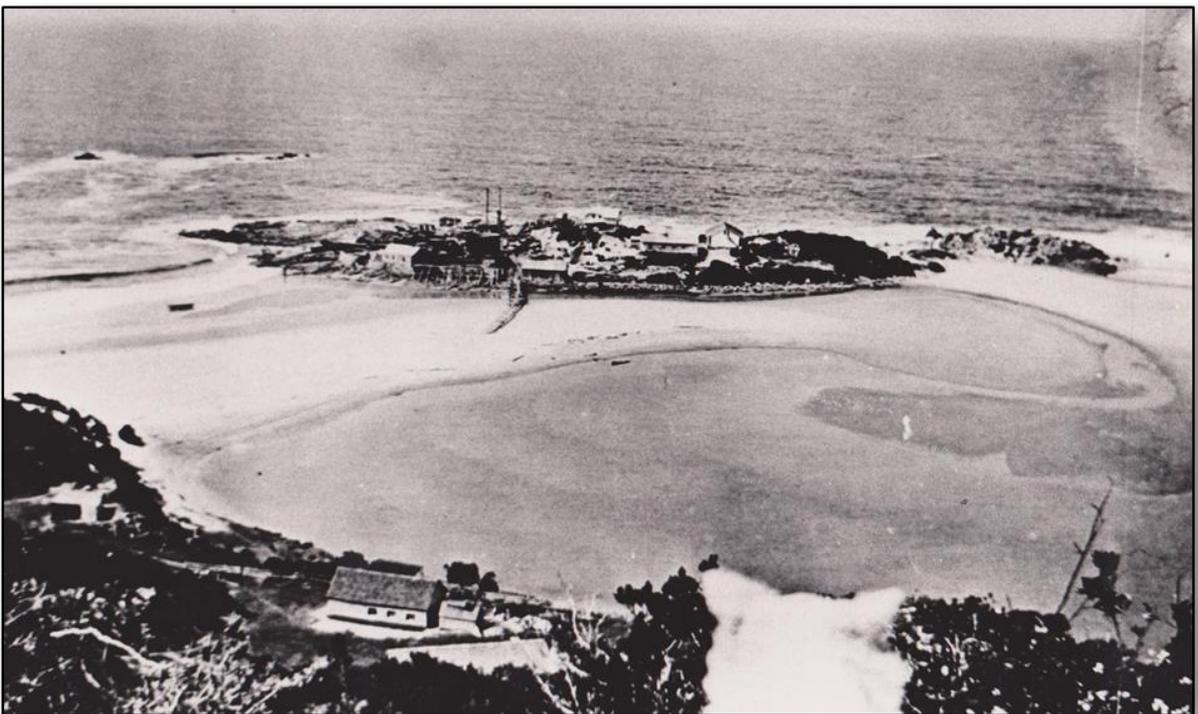
**Figure 5: Piesang River estuary inlet channel meandering out to sea with an extensive s-curve**

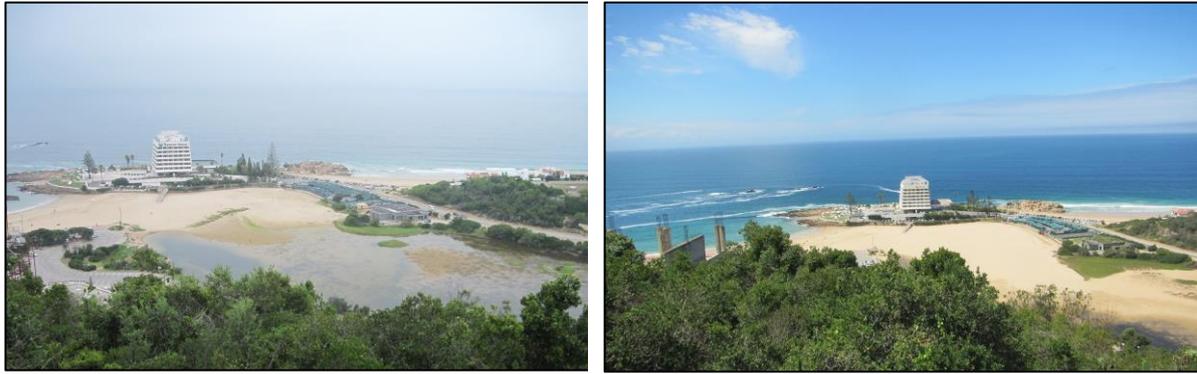
**Figure 6: Photographs from 21 February 2011 (left) and 2018 (right) showing extensive build-up of sediment in the lower Piesang River estuary and low water levels**

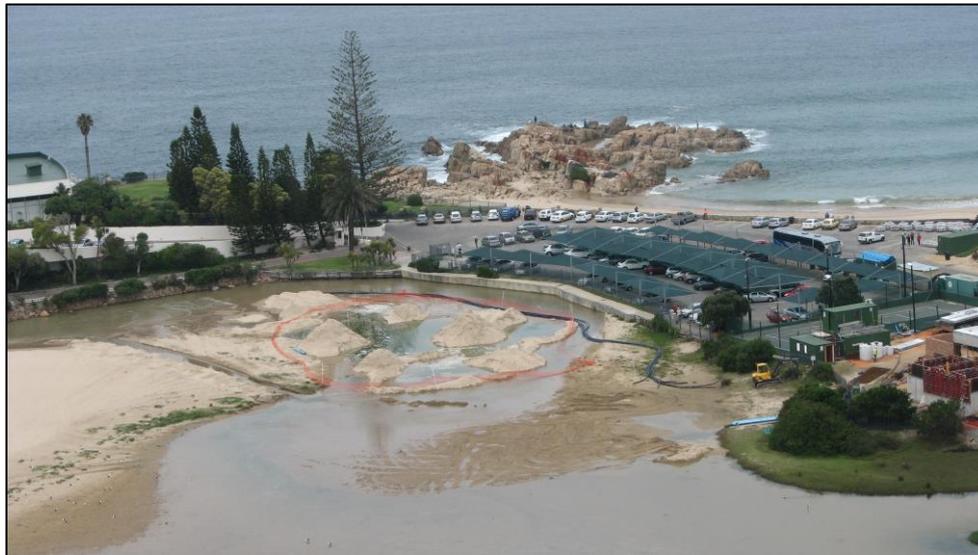
**Figure 7: Construction of reverse osmosis plant in Piesang River estuary on 3 November 2010 (Photo: P Huizinga)**

Since 2010, a reverse osmosis plant (see Figure 7) has started taking water directly from the Piesang River estuary leading to an increase in closed mouth conditions when it is operating and a decline in water levels under the closed mouth state (DWS 2015). During 2018 the water levels in the Piesang River estuary were alarmingly low (Figure 7).

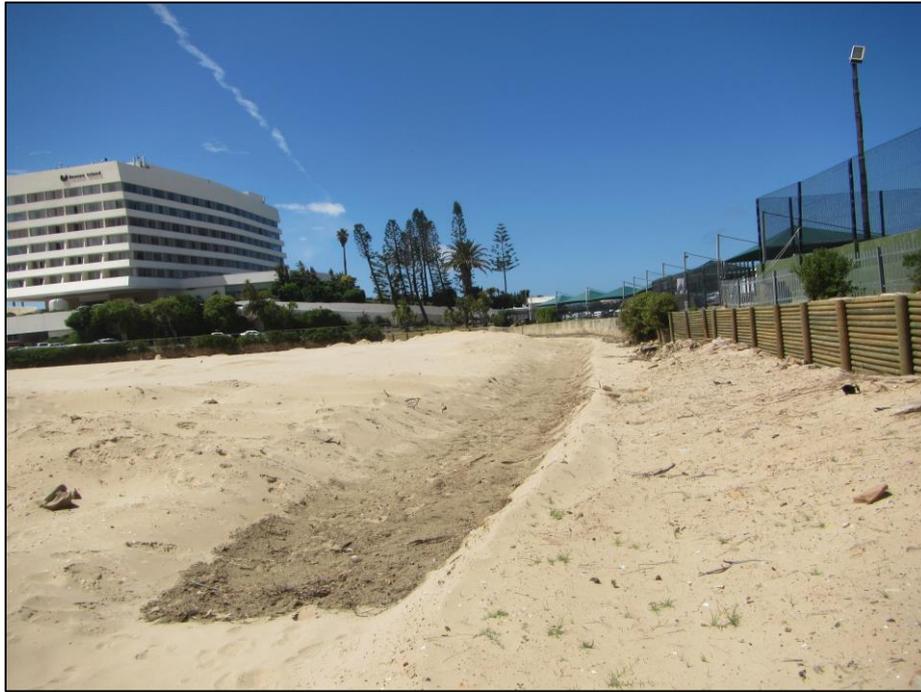
**Figure 8: Unsuccessful excavation channel running from the mouth to the well field  
(Photo: Lara van Niekerk)**

In an unsuccessful attempt to facilitate seawater intrusion onto the well field area in the lower estuary during an extended closed phase, an inlet channel was excavated from the mouth to the reverse osmosis plant (Figure 8). However, this practise is strongly discouraged as it can cause further long-term sediment intrusion into the lower estuary during storm events, compounding the issue of reduced open water area and potentially disrupt the natural salinity profile of the estuary. Such interventions would thus further degrade the estuary physical processes which support its ecological functioning and which in turn are driving the system into an altered state of a lower ecological value.

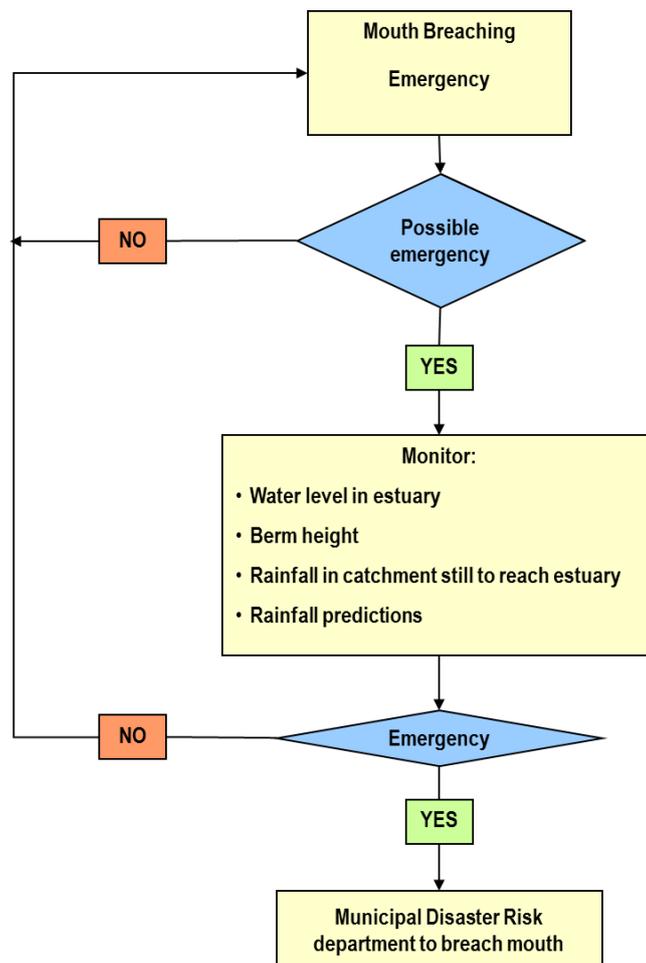
**Figure 9: A flow chart illustrating the breaching plan for emergency conditions**

A flow chart for the undertaking of mouth breaching under emergency conditions is included in Figure 9. Emergency breachings should be undertaken in the swiftest manner possible according to this Estuary MMP.

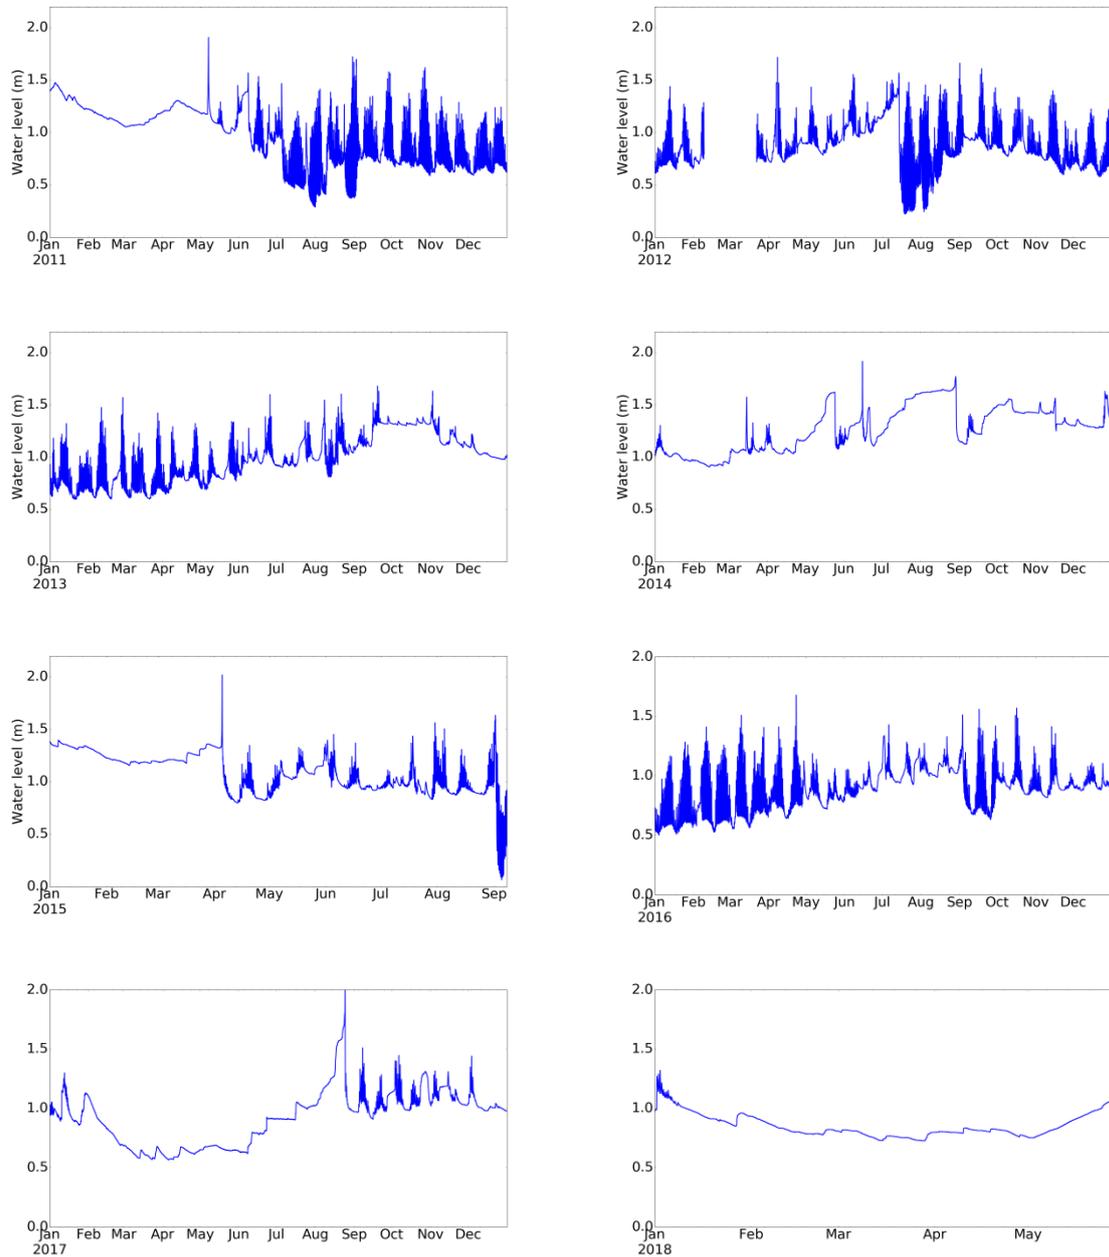
**Figure 10: DWS tidal gauge K6T021 level to mean sea level (MSL) for period December 2011 to June 2018.**

Water level data were only available from 2010 for the Piesang River estuary (Table 3 and Appendix A). The data show that the estuary was mostly open or partially open from about mid-2011 to October 2013. The system was mostly closed with overwash in 2014 to about April 2015. From then onwards the estuary was mostly open again till December 2016, albeit at times with a small tidal amplitude and ingress by significant overwash during spring tides. However, from January 2017 to May 2018, the estuary closed, with only limited overwash during September to December 2018 connecting it to the sea. This period correlates with a very low river inflow of 0.05 m<sup>3</sup>/s measured during that period. What is also clear from the water level data is how low the water was during the 2017/18 closed period (between 0.5 and 1.0 m) in comparison with other closed periods (between 1.0 and 1.5 m).
