# **Mouth Management Plan**

## **Verlorenvlei Estuary**

Verlorenvlei Estuary Mouth Management Plan

Western Cape Estuary Management Framework and Implementation Strategy

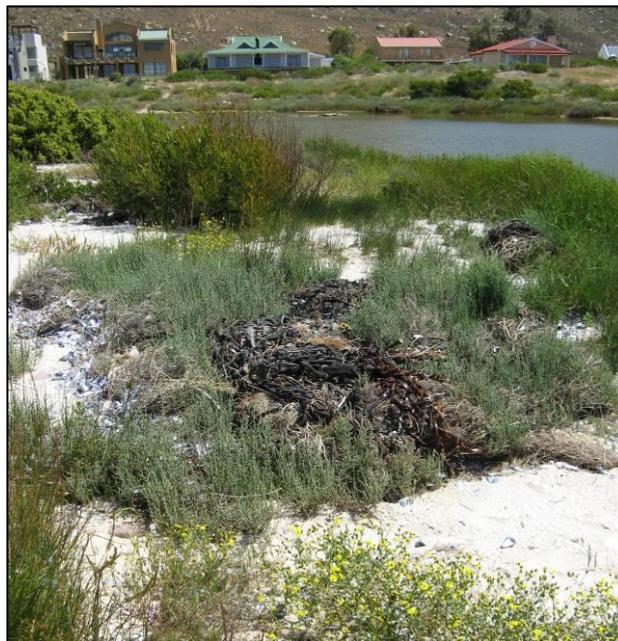
**Figure 1: Dried kelp wrack on inside of Verlorenvlei sand spit**

Tidal exchange continues until the velocity of the outflowing water decrease sufficiently so as to allow the accretion of sand to form a new bar at the mouth. During storms and high spring tides the sea washes over the sandbar (Figure 1). Sea water is reported to penetrate as far as Verloren Farm (Robertson 1980).

**Sandbar at the Mouth:** The rocky barrier at the mouth (~1 m MSL) is covered by a 1 to 2 m thick sand layer (Figure 2). Since mean high tide is about 0.8 m MSL, overwash from the sea can only occur during high spring tides and storm surges. Evidence of overwash is clearly to be seen as dried kelp wracks on the sand spit near the mouth or decaying pieces of kelp in the lower mouth area (Figure 1). During a November 2008 field visit the mouth of the Verlorenvlei was open, but perched, with fresh water running strongly out to sea on the ebb tide and entering the estuary in a very limited manner on the flood tide, i.e. the mouth acted as a natural constriction to tidal flows.

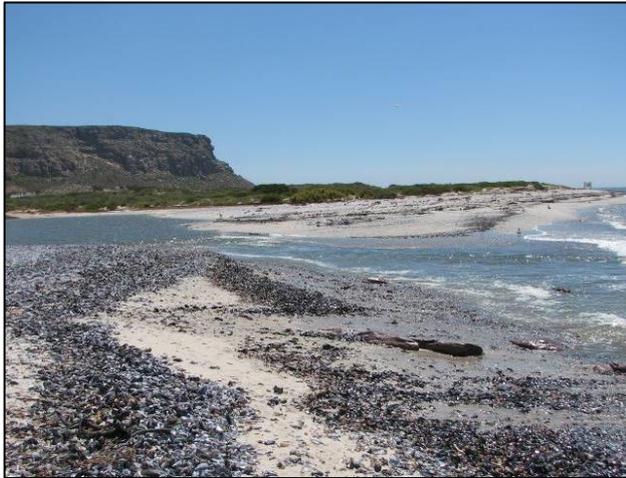
Sandbar at the mouth of Verlorenvlei, November 2008

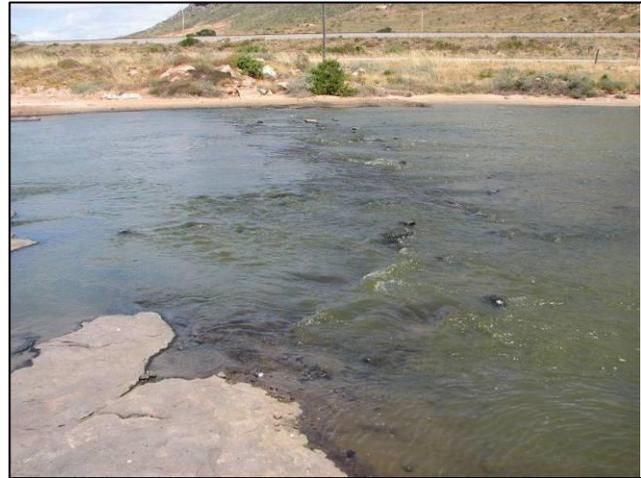
The rocky sill causing a natural obstruction to tidal exchange about 500m from the mouth

**Rocky sill 500m from the mouth** (Figure 2): This rock feature allows for free outflow of water from the vlei, but still acts as a natural obstruction to normal tidal flows. Seawater is only expected to penetrate beyond this point during high spring tides and storm surges. Although this rocky sill represents a hydraulic constriction to tidal flows it is deep enough to allow for the recruitment of invertebrates and fish into the system. This was demonstrated during a November 2008 field visit by the presence of the first recorded juvenile steenbras in Verlorenvlei since the 1970s.

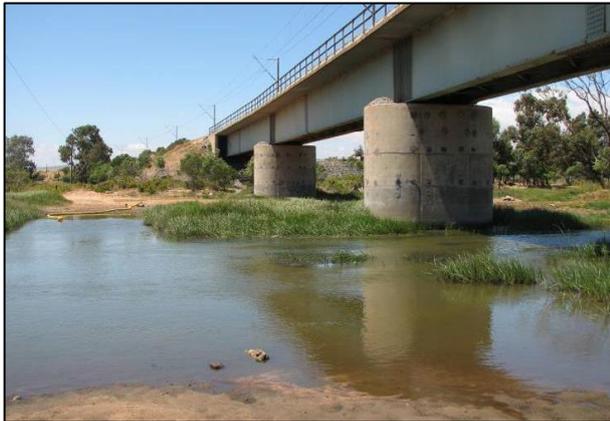
Railway bridge crossing

**Railway bridge crossing:** The railway bridge crossing is situated about 1 km from the current mouth position, and used to form part of the maintenance road that runs along the Sishen/Saldanha railway line (Figure 2). The road was raised 1 m above the river bed on a crude rubble and clay causeway until removal in 2012. It prevented a free connection to the vlei and reduced the nursery function of the system. The causeway was temporarily reinstated during 2015 as part of upgrade works on the main road crossing further upstream, but has since been removed.

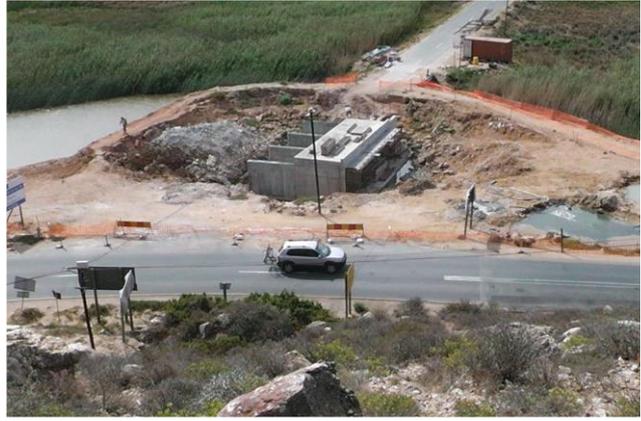
2015 Refurbishment of the road bridge culverts

**Road crossing:** The main road to Elands Bay from Dwarskersbos crosses the uppermost narrow section of the estuary channel (2.6 km upstream of the mouth) via a recently upgraded 275 m – long embankment about 2 m above the lake bed level. The 2014/15 road upgrades installed new box culverts which allow flow to pass through against the southern bank of the channel (Figure 2). Although this constriction does not pose a major constraint to flow under normal conditions, it does prevent normal circulation and, in the past, has contributed to the substantial vegetation growth in the lower vlei. The culverts also are a constriction under flood conditions and contribute to backflooding of adjacent land.

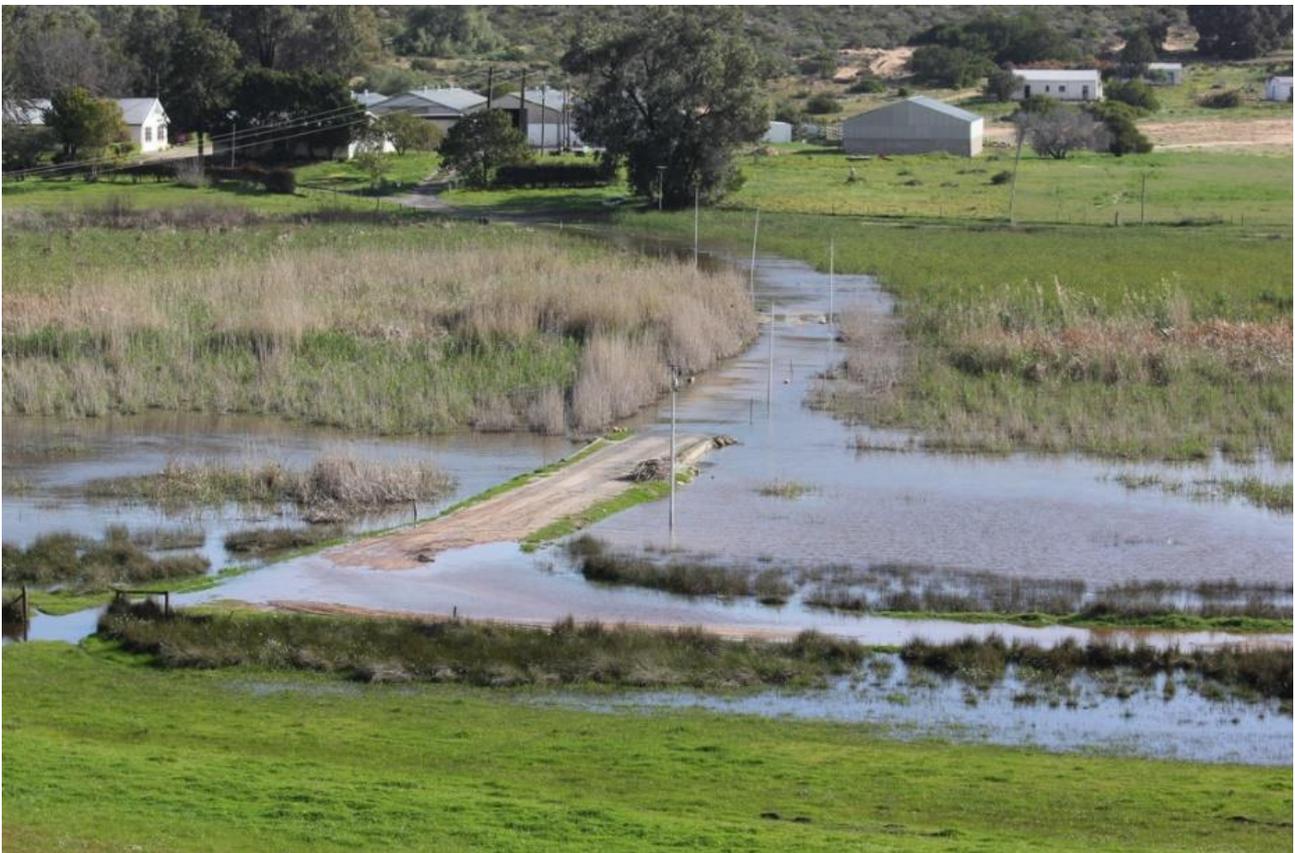
**Grootdrift causeway:** The causeway at Grootdrift hinders the natural meandering of the channel and flow in the upper vlei. The causeway only allows limited flow through 4 sets of culvert structures, retarding flow both up and downstream (Figure 3). The main culvert in the main channel consists of 15 pipes (Figure 4). The result is more stagnant conditions and a related increase in sedimentation and vegetation growth. It is very important that an effort be made to increase the flow through the causeway.

**Figure 3: Grootdrift causeway obstructing flow going upstream (photo is looking South) (21 August 2013) (Nick Taylor)**

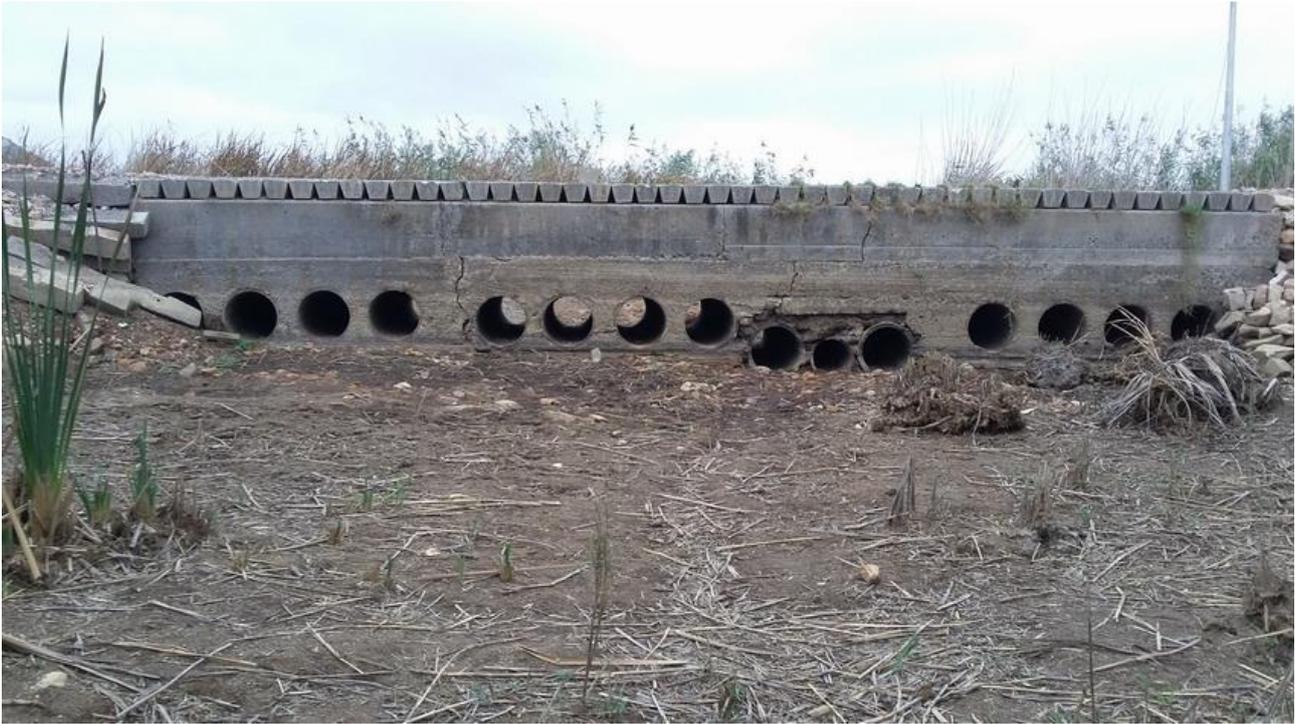
**Figure 4: Main Grootdrift culvert structure (12 May 2016) (Photo: Charles Malherbe)**

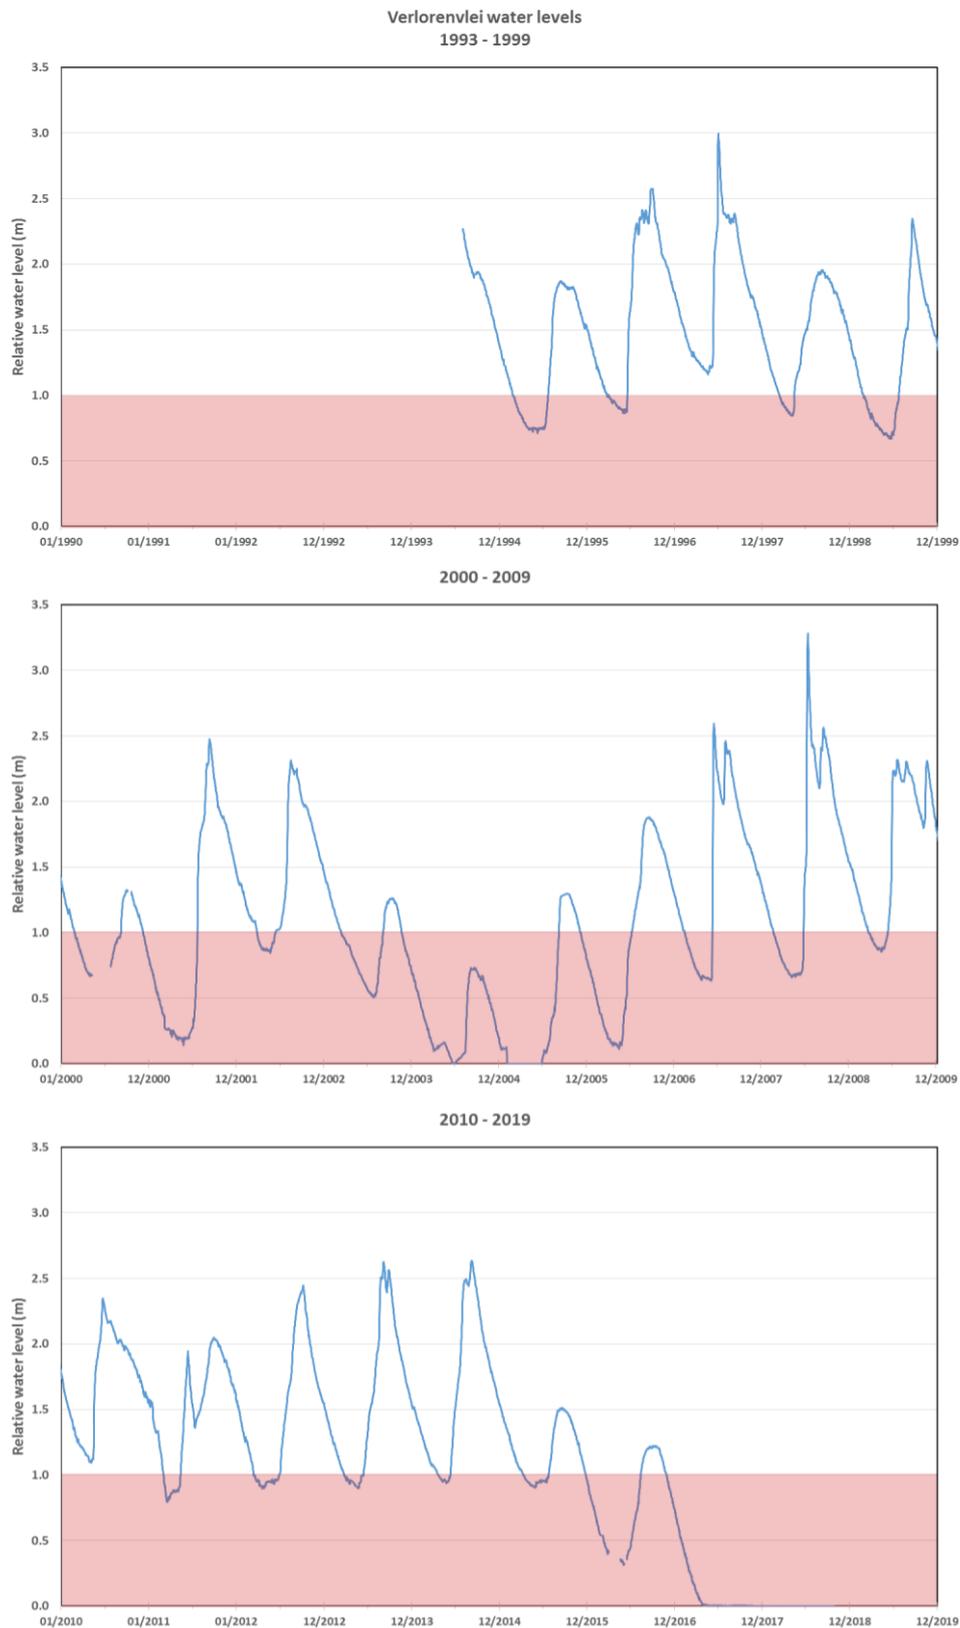
The relative water levels recorded at DWS gauging station DWS Gauge G3T001 from 1993 to 2019 are shown in Figure 5. Low water levels are shaded in red on the graphs. Note however that the recorder “bottoms out” and cannot record values below 0.

**Figure 5: Relative water levels at DWS Gauge G3T001 for 1993 to 2019, with extremely low levels indicated by red shading. Note water level recorder does not record values less than 0 m.**

Relative high water levels also occurred in 1996, 2006, 2013, and 2014. After the mouth was illegally artificially breached in 2014 the water level (as recorded at the DWS gauge) continued to rise for several days due to the construction works on Elands bay road bridge and the associated coffer dam. Water level continued to rise until 7th/8th September and only dropped below the 29th July level on 18th October 2014.

More concerning is the increasing incidences of very low water levels in the vlei, with 2000, 2003, 2004, 2015, 2016 to 2019 being the lowest on record. Under these extremely low water levels large parts of Verlorenvlei are dry at times (Figure 5 and 7).

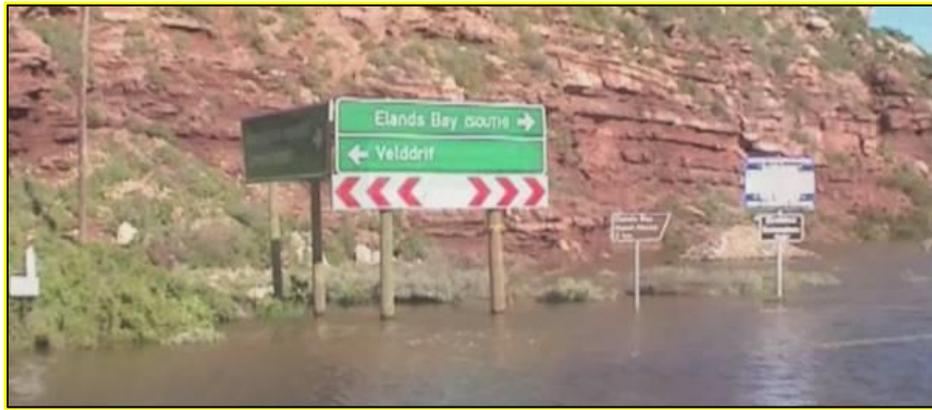
The highest water level on record was during the July 2008 flood, when Verlorenvlei was able to breach on its own. Measurements at the DWS gauge plate indicated that it was 3.284 m. A screenshot of the road bridge from 2008 Flood Video (N Taylor & F Strange) is shown in Figure 6.

**Figure 6: High water levels observed near causeway on 11 July 2008 (Source: N Taylor).**

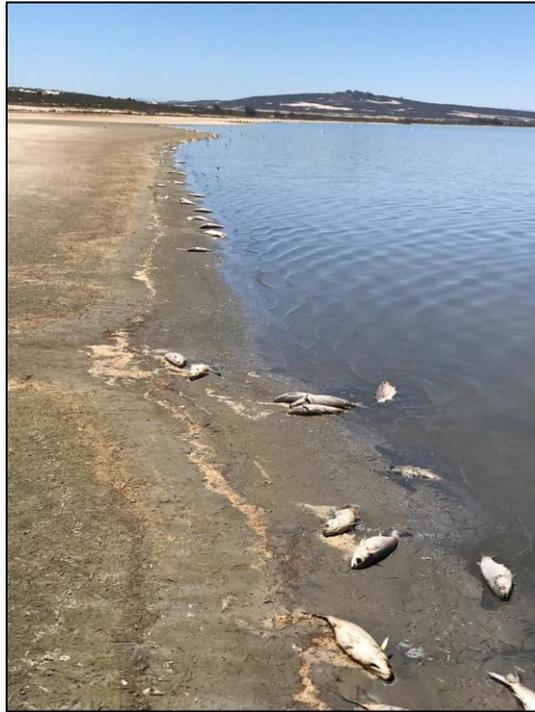
Lower water levels in turn are associated with fish kills and a loss of bird life (Figure 8). In February 2019 there was a fish kill of large fish in the system, comprising about 90 % springers *Mugil cephalus*, 5 % Mozambique tilapia *Oreochromis mossambicus*, 3 % carp *Cyprinus carpio* and 2 % other. Small dead fish comprised 99% estuarine round-herring *Gilchristella aestuaria*. Surprisingly, no harder *Chelon richardsonii* were recorded which is usually the dominant fish in Verlorenvlei. Mullet are very resilient to poor water quality, often feeding on *Microcystis* and other blue-green algae, so they may have been hiding out in the deeper areas of the vlei.

**Figure 8: Fish kill at Verlorenvlei, February 2019 (Source: F Strange)**

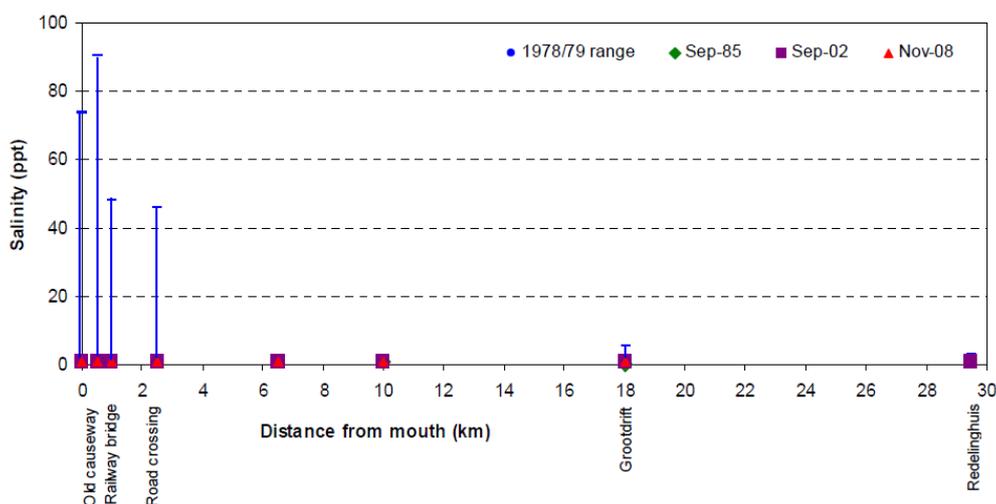
Salinity data on Verlorenvlei is summarised in Figure 9 (Robertson, 1980; Grindley *et al*, 1980; DWAF 2003; Verlorenvlei SAR study). Verlorenvlei normally functions as a freshwater system: the mouth is perched and only allows occasional seawater inflow during high spring tides and stormy conditions at sea. When water levels in the vlei are high, there is a continuous discharge to the sea maintaining freshwater dominated conditions as was observed in September 1985, September 2002 and November 2008 (Figure 9). When the water level in

**Figure 9: Summary of salinity data collected in Verlorenvlei between 1978 to 2008**

the vlei drops, the outflow to the sea no longer occurs, creating a stagnant water body in the lower reaches. During these low water levels the shallower areas - downstream of the road crossing – can become more saline, even hypersaline when interchanges of fresh water between the larger vlei and this shallow regions are no longer sufficient to counterbalance salt build-up associated with occasional overwash and evaporation. Such conditions were evident in 1978/79 when a drought resulted in a marked drop in water levels and when the old causeway and railway service road were still present, preventing proper exchange between the shallower area and the larger estuary.

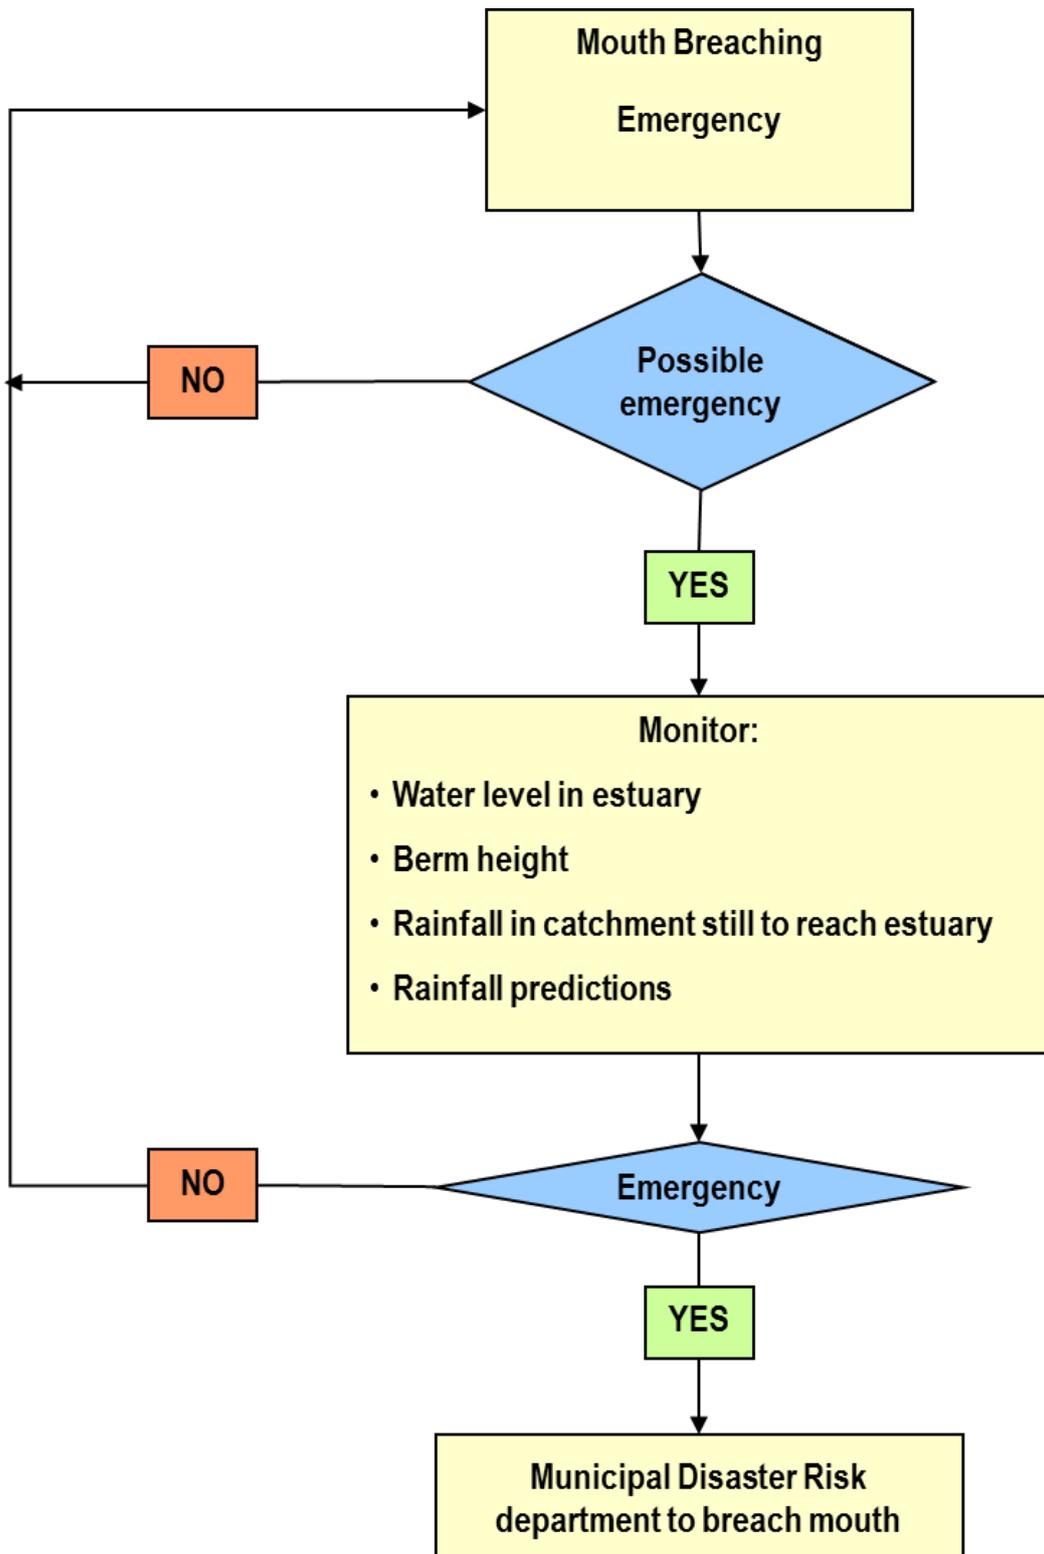
A flow chart for the undertaking of mouth breachings under emergency conditions is included in Figure 10. Breachings should be undertaken in the swiftest manner possible and in most cases the Disaster Risk Department of the local municipality is responsible. While breaching should be conducted according to an Estuary Mouth Management Plan, some of the general breaching principals may be waived under emergency conditions to ensure an expedient breaching.

Figure 10: A flow chart illustrating the breaching plan for emergency conditions
