# Economic valuation of the averted degradation of the Vyeboom Wetland in the Theewaterskloof Dam catchment, South Africa

**Figure 1.** Overview of Theewaterskloof Dam and the position of the Vyeboom Wetland

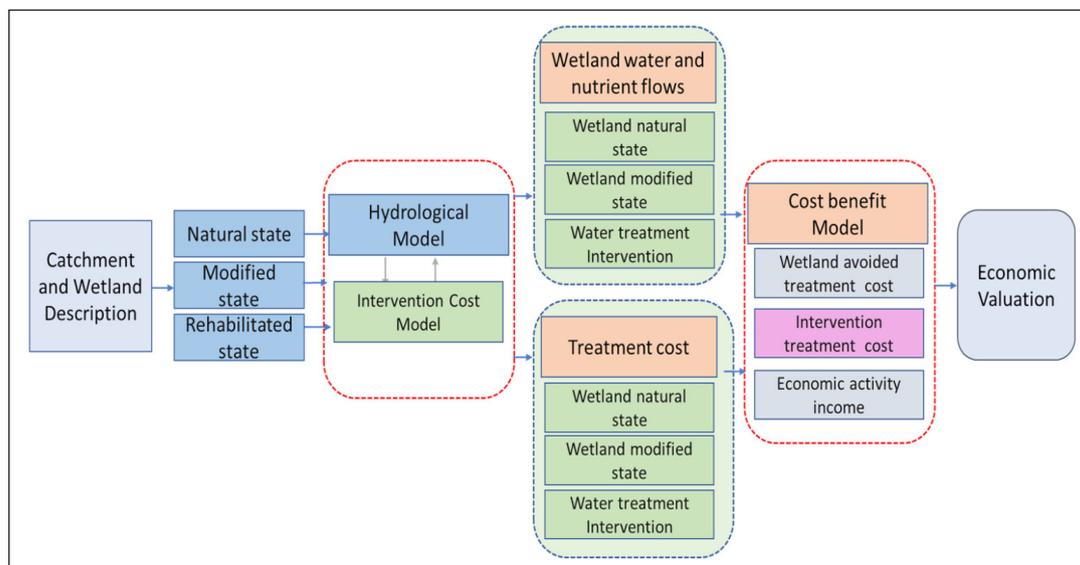
**Figure 2.** Wetland valuation study framework

The essence of the wetland valuation process is captured in the framework depicted in Fig. 2.

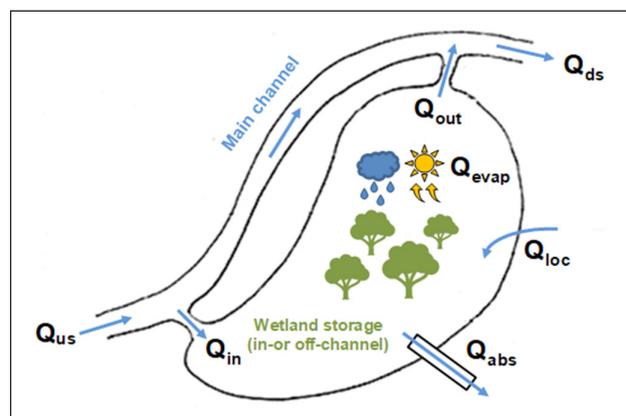
Figure 3 shows a diagram illustrating the flow balance through the wetland module in the WRS2000/Pitman Model. The simulated upstream main channel inflow to the wetland ( $Q_{us}$ ) represents the inflow from the total upstream catchment area which is continuously connected to the wetland storage area or only under certain flow conditions.  $Q_{ds}$  represents the downstream outflow of the main channel. The latter conditions usually occur when there is a well-defined main channel such as in the case of strong perennial rivers, where an off-channel storage wetland often only fills under higher flow conditions, such as is the case for the Vyeboom Wetland where the Upper Riviersonderend feeds into the wetland as a main channel from the mountainous catchment areas.

**Figure 3.** Flow balance diagram of the WRS2000/Pitman wetland sub-module (adapted from Bailey (2015))

Other, more localised simulated runoff (usually lateral inflow) is also catered for in the module ( $Q_{loc}$ ). The localised runoff has direct access to the wetland storage area and is not limited by flow conditions in the main channel. A real wetland has many links, where water can flow from the main channel to the wetland storage area and back into the channel, depending on water levels.

The flow from the main channel to the wetland storage area ( $Q_{in}$ ) and from the storage area to the main channel ( $Q_{out}$ ) are regulated by several module parameters.

The monthly wetland water storage balance is calculated using  $Q_{in}$ , the nominal monthly storage status of the wetland, the net monthly evaporation ( $Q_{evap}$  – the difference between the month's evaporation and rainfall) and  $Q_{out}$  (Bailey, 2015). The sub-module also requires some physical parameters such as the wetland storage capacity, surface area and some calibration parameters that regulate the rate of inflow and outflow from the wetland storage area.

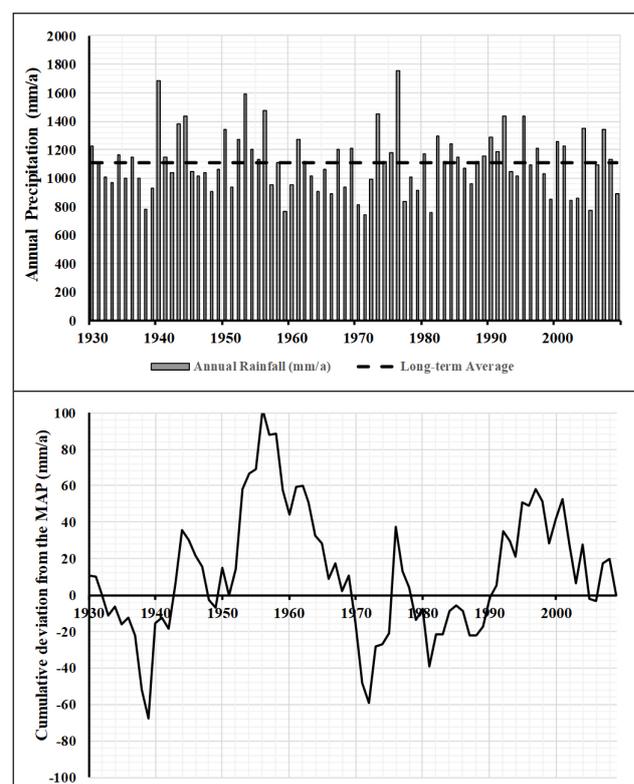
Figure 4. Theewaterskloof Dam long-term catchment rainfall characteristics

Long-term catchment-based rainfall time-series were generated for the Theewaterskloof Dam from patched monthly point rainfall station data within and from surrounding catchment areas. The point rainfall data were obtained from WR2012 study (Bailey and Pitman, 2015). Figure 4 shows the long-term annual catchment rainfall and the cumulative deviation from the long-term mean annual rainfall for the Theewaterskloof Dam catchment. Table 2 provides the estimated annual evapotranspiration for each group of plants. Figure 5 provides the approximate monthly distribution for the wetland compared to the S-pan evaporation for quaternary catchment H60A, predominantly on the western side of the Theewaterskloof Dam. The final present-day development level long-term average annual flow water balance for the Vyeboom Wetland is provided in Table 3.

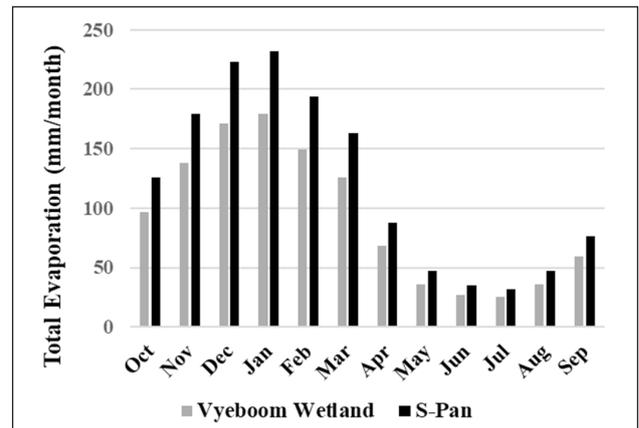
**Figure 5.** Estimated monthly evapotranspiration from Vyeboom Wetland

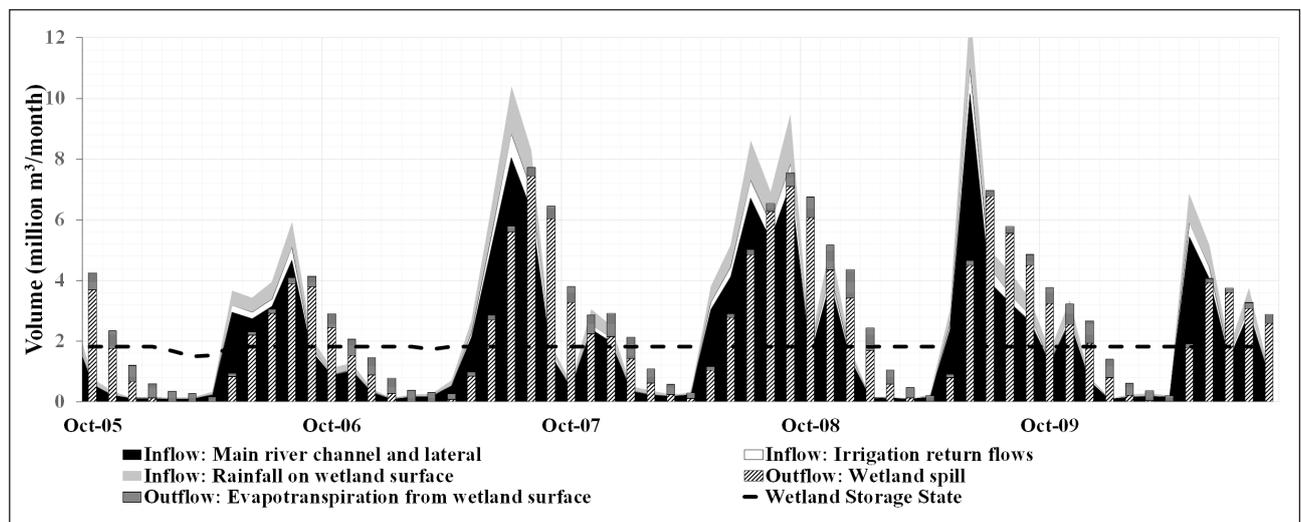
**Figure 6.** Excerpt of the Vyeboom Wetland long-term water balance simulation for Present Day development scenario, only showing the last 5 years of the 80-year simulation results

The Vyeboom wetland long-term water balance is illustrated in Fig. 6, showing only the last 5 years of the Present-Day development scenario. The capacity of the wetland is far exceeded by the total wetland inflow for most months. As can be seen from Table 3, the lateral inflows dominate the inflow to the wetland store since these flow directly into the wetland storage, which causes most of the main channel inflow bypassing or flooding of the wetland storage.

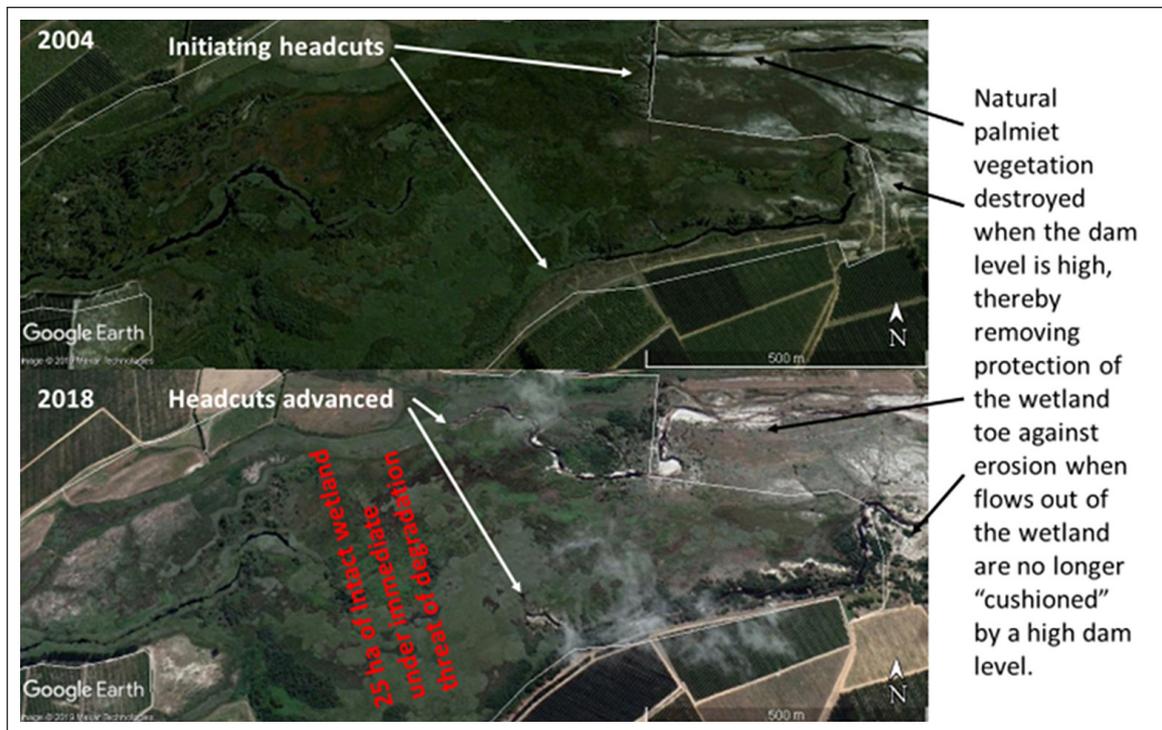
Figure A1. The area of HGM 3 of the Vyeboom Wetland which is under high threat of future erosion, shown in 2004 and 2018

using wetland size (a simple surrogate for mean annual runoff) and wetland longitudinal slope. Furthermore, no impediments to erosion (e.g., a geological obstruction) occur within HGM 3 which might halt the future advance of headcut erosion.

In terms of anthropogenic disturbance, the fluctuating level of the Theewaterskloof Dam appears to be a potentially important factor contributing to headward erosion of an extensive area of weakly channelled wetland lying immediately upstream of the dam and extending below the full supply level of the dam (Fig. A1). This begins during a period when the dam is full or near-full and the lowermost portion of the wetland becomes flooded, which in turn drowns the vegetation covering this area. When the level of the dam drops, which is often rapid, the downstream portion of the wetland is left without vegetation and exposed to erosion. Furthermore, the base level of the wetland, previously provided by the highwater level of the dam, is now often several metres below the wetland, and therefore has no controlling influence over water flowing out of the wetland, further amplifying the vulnerability of the wetland to erosion.
