# **Mouth Management Plan Klein River Estuary**

Klein River Estuary Mouth Management Plan

Western Cape Estuary Management Framework and Implementation Strategy

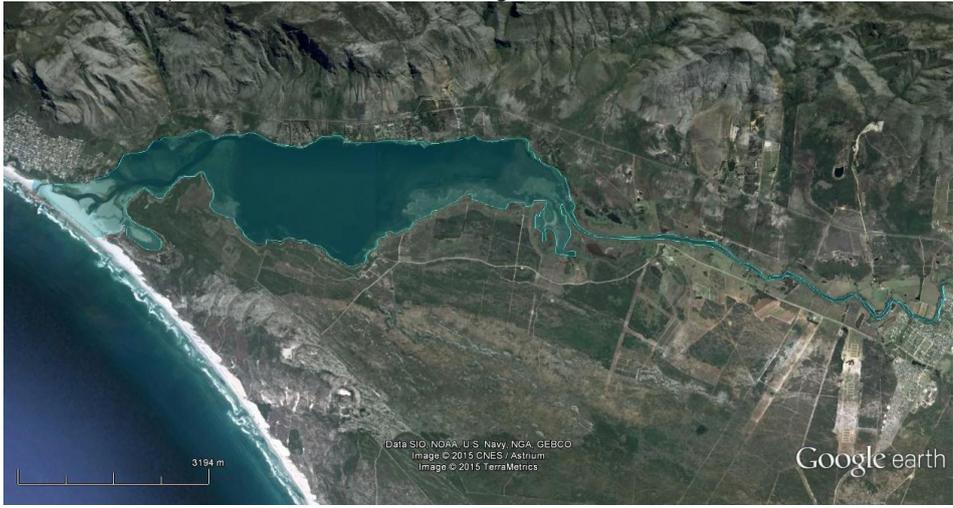
Threat	Discussion
<p><b>Location</b></p>	<p>The Klein River Estuary - popularly known as Hermanus Lagoon or Kleinriviersvlei – is situated more or less midway between Cape Point and Cape Agulhas on the south-west coast within the cool temperate biogeographic region of South Africa. The geographical boundaries for the study are defined as follows (Clark et al. 2015):</p> <ul style="list-style-type: none"> <li>• Downstream boundary: Estuary mouth 34°24'58"S 19°17'35"E</li> <li>• Upstream boundary: 34°25'53"S, 19°27'30"E</li> <li>• Lateral boundaries: 5 m contour above Mean Sea Level (MSL) as depicted by the Estuary Functional Zone below in light blue.</li> </ul>
